Appendix 9.5 AECOM Transportation: Road Safety Audit - Ballyragget

ESB Site Access Ballyragget – Stage 1/2 Road Safety Audit

Job No 60273241

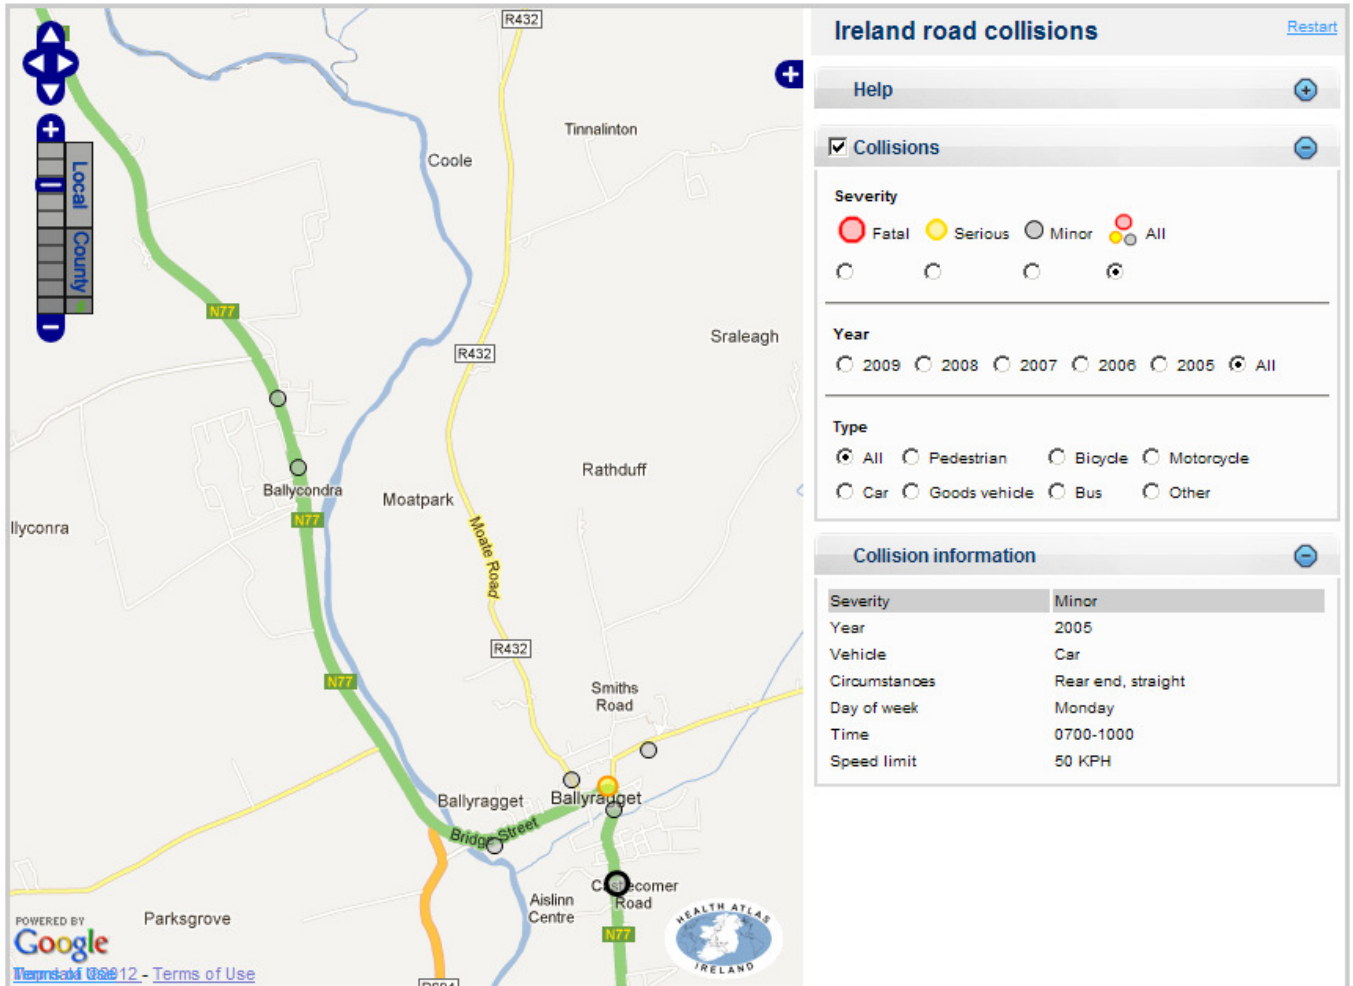
- The Road Safety Authority database of personal injury accidents was interrogated to establish if there are any existing safety issues in the vicinity of the development that are not evident from the site visit. The period of accident data examined is from 2005-2009.
- The records indicate that there were no accidents in the vicinity of the proposed works.

Figure-2: RSA Accident Records (2005-2009) in vicinity of proposed scheme (www.RSA.ie)
