## **Appendix 9.4 AECOM Transportation: Road Safety Audit - Coolnabacky**

# **ESB Site Access Timahoe – Stage 1/2 Road Safety Audit**

Job No 60273170

Date Created Sept 2012

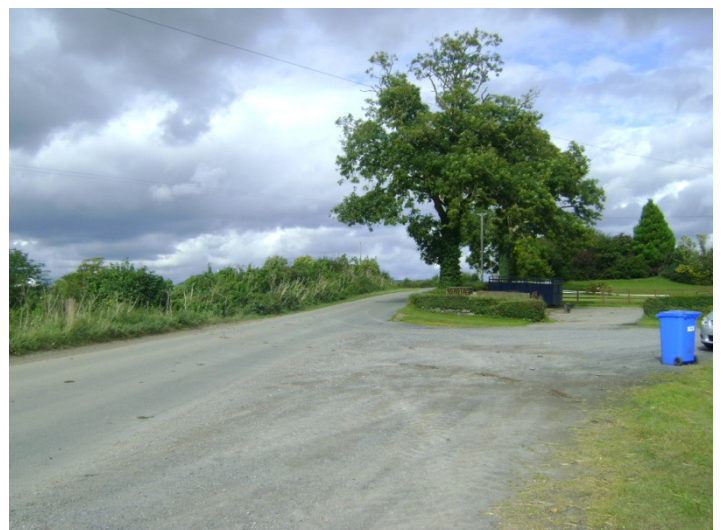
- The R426 is approximately 5.5m wide in the vicinity of the proposed site access, and runs in a north south direction fronting the site.
- Visibility to the north (right) from the proposed access road is restricted due to a large tree. The road rises from the site access for a distance of 100m before it levels off and bends to the west.
- Visibility to the south (left) from the proposed access road is approximately 70m. The road is relatively level heading south, and bends slightly to the east.
- No road markings were visible on the road fronting the proposed access road.

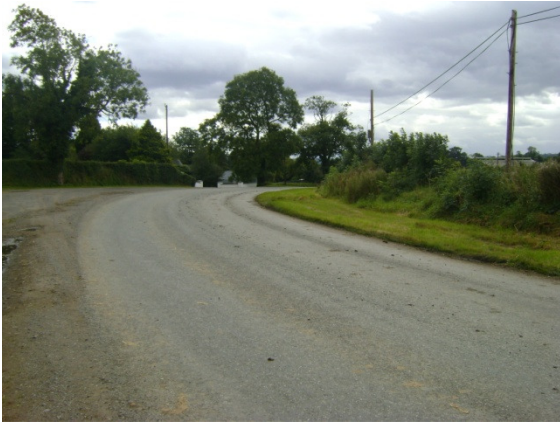
*Photo 1: R426 looking south towards site access*

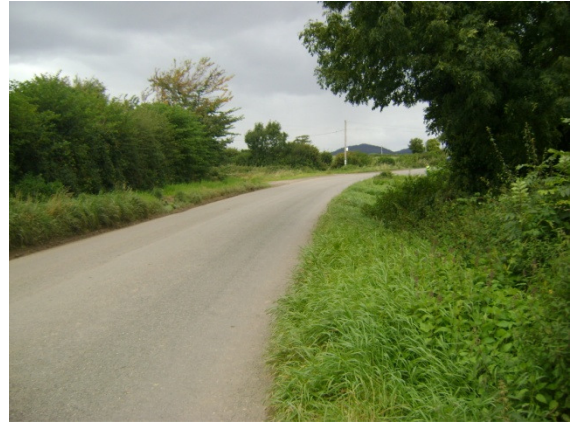
*Photo 2: R426 looking north towards site access*

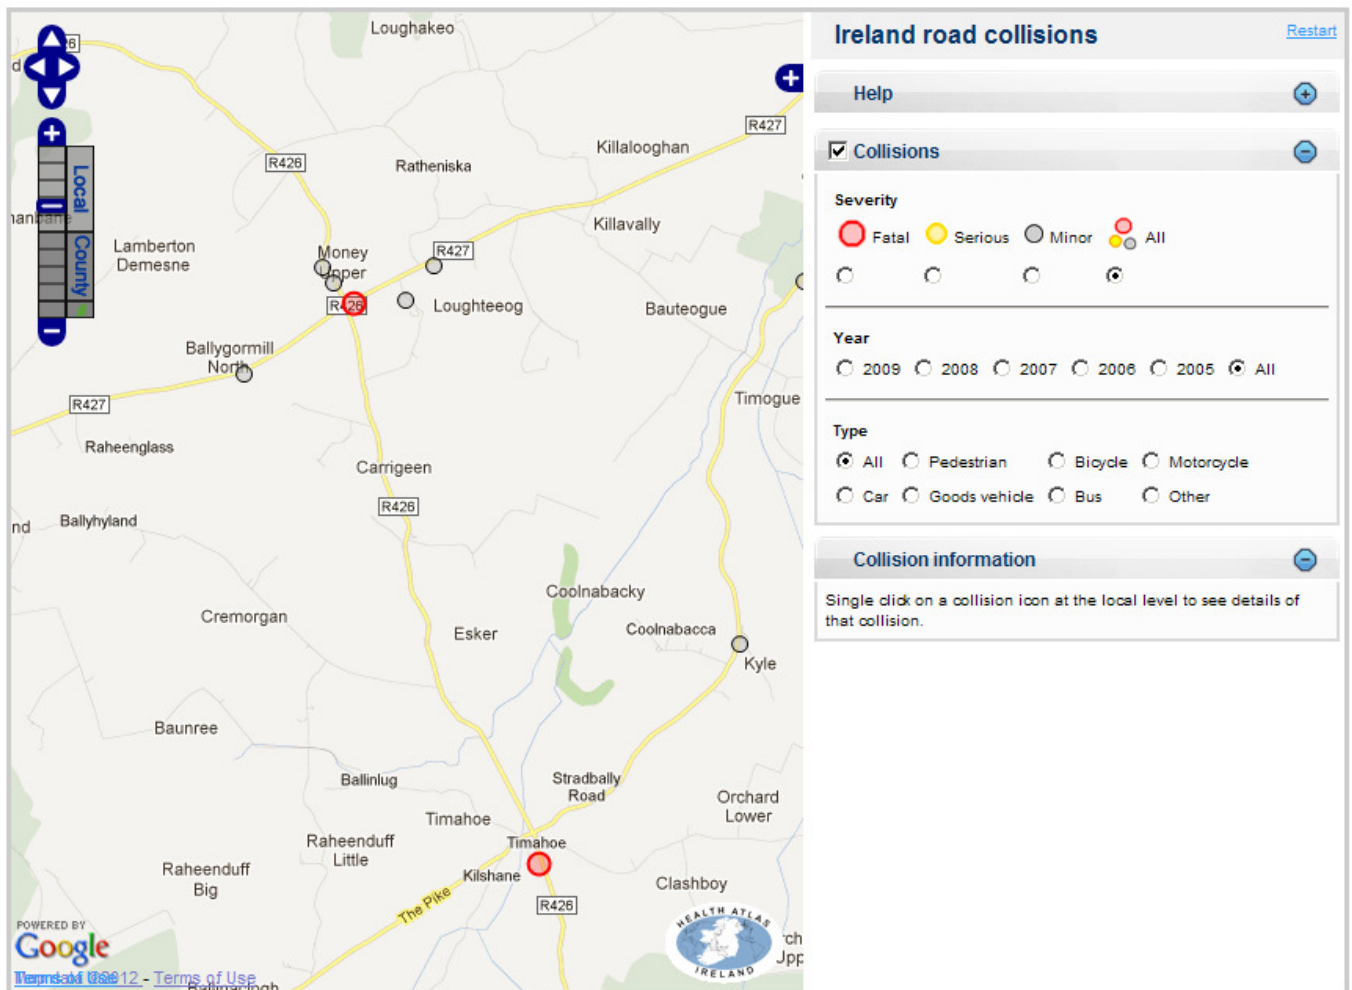
- The Road Safety Authority database of personal injury accidents was interrogated to establish if there are any existing safety issues in the vicinity of the development that are not evident from the site visit. The period of accident data examined is from 2005-2009.
- The records indicate that there were no accidents in the vicinity of the proposed works.

Figure-2: RSA Accident Records (2005-2009) in vicinity of proposed scheme ([www.RSA.ie](http://www.RSA.ie))

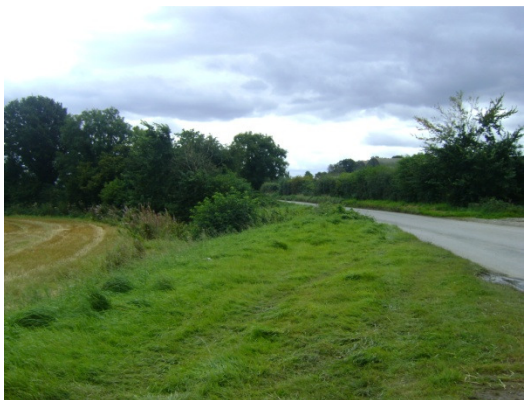
<b>4.2.1 Problem</b>

<i>Location:</i>	Proposed Access Road	
<i>Drawing:</i>	60241205-001	
<i>Summary:</i>	Visibility to the south	
<i>Description:</i>		
Visibility to the south (left), from an approximate 3m setback for drivers exiting the site access road is restricted due to the alignment of the R426 road and trees/vegetation. This may lead to vehicles encroaching into the carriageway to achieve adequate visibility resulting in side-impact collisions and/or head on collisions as a result of vehicles on the R426 swerving to avoid exiting vehicles.		
<b>Recommendation:</b>		
Provide adequate visibility for vehicles exiting the access road. This should take account of the speeds on the R426. Guidance is available in the Design Manual for Roads and Bridges.

4.2.1	Yes	Yes/No	It is proposed to remove vegetation within the verge area to the south of the proposed access within the extents of the lands in the control of the applicant, to improve visibility. In terms of overall visibility requirements for the road type and vehicle speeds recorded/observed, the Design Team were advised by Laois County Council Roads Department that given the proposed access represents an improvement on the existing access, and that the likely trips generated by the proposed development during operation are marginal compared to current usage, the Authority would not see any significant safety issues arising from such a proposal.

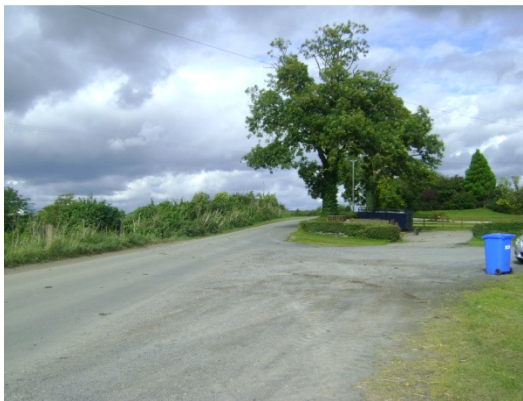
<b>4.2.2 Problem</b>

<i>Location:</i>	Proposed Site Access Road	
<i>Drawing:</i>	60241205-001	
<i>Summary:</i>	Visibility to north	
<i>Description:</i>		
Visibility to the north (right) from an approximate 3m setback for drivers exiting from the access road is restricted due to a single large tree located along the R426. This may lead to vehicles encroaching into the carriageway to achieve adequate visibility resulting in side-impact collisions and/or head on collisions as a result of vehicles on the R426 swerving to avoid exiting vehicles.		
<b>Recommendation:</b>		
Provide adequate visibility for vehicles exiting the substation access. This should take account of the speeds on the R426. Guidance is available in the Design Manual for Roads and Bridges. This could be achieved by removing the large tree.

4.2.2	Yes	Yes	It is proposed to remove the tree located immediately to the north of the existing access on the east side of the R426.
4.2.3	No	No	The proposed access has a 10m radius on both the north and south edge lines entering the road from the R426, in accordance with para.7.27 of NRA DMRB TD41-42/11. During normal operations only light vehicle/van access is expected to the proposed substation and typical existing farm access movements to and from the R426 would relate to a tractor and trailer unit, for which the 10m radius is suitable. In the unlikely event of a larger vehicle being required to access the substation for maintenance reasons, appropriate measures such as banksmen and temporary signage will be implemented on the R426 during movements to/from the site.

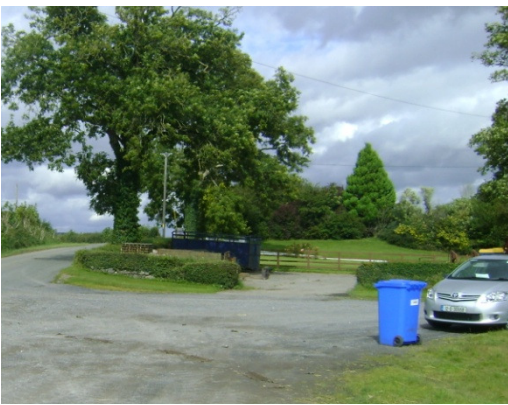
<b>4.2.4 Problem</b>

<i>Location:</i>	Existing Farm Yard Access	
<i>Drawing:</i>	60241205-001	
<i>Summary:</i>	No details provided	
<i>Description:</i>		
<p>Access is currently provided to a farm yard, located on the existing access road, approximately 10m from the R426 road edge. The proposed scheme plans to realign the access road, by moving it approximately 20m south. No details have been provided regarding arrangements for the farm access.</p> <p>Failure to provide an appropriate access arrangement for vehicles entering and existing the farm yard may bring these vehicles into conflict with vehicles on the access road/R426, thus increase the risk of collision.</p>		
<b>Recommendation:</b>		
Details of the access arrangements for the farm yard should be provided prior to construction.

4.2.4	No	No	It is proposed that the existing access to the dwelling/yard will be retained, in accordance with the requirements of the landowner, but it will be separated from the proposed access road by an appropriate boundary treatment. Both the existing access and the proposed new access have good visibility of each other, and having regard for the low volumes generated, no conflict or interaction is expected.
