## **Appendix 11.4 AECOM Transportation: Road Safety Audit - Coolnabacky**

# ESB Site Access Timahoe – Stage 1/2 Road Safety Audit

Job No 60273170

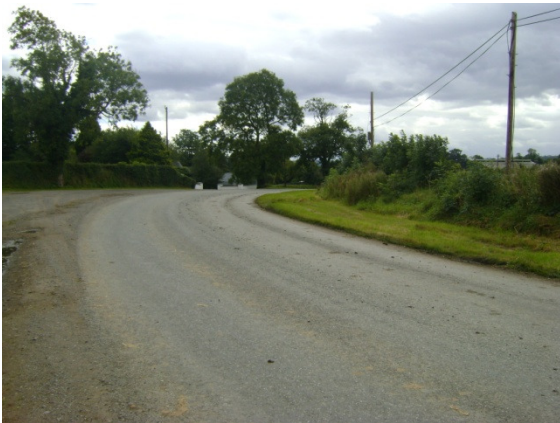
*Photo 1: R426 looking south towards site access*

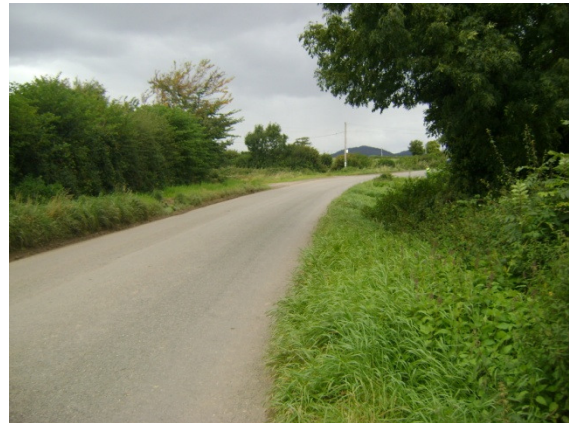
*Photo 2: R426 looking north towards site access*

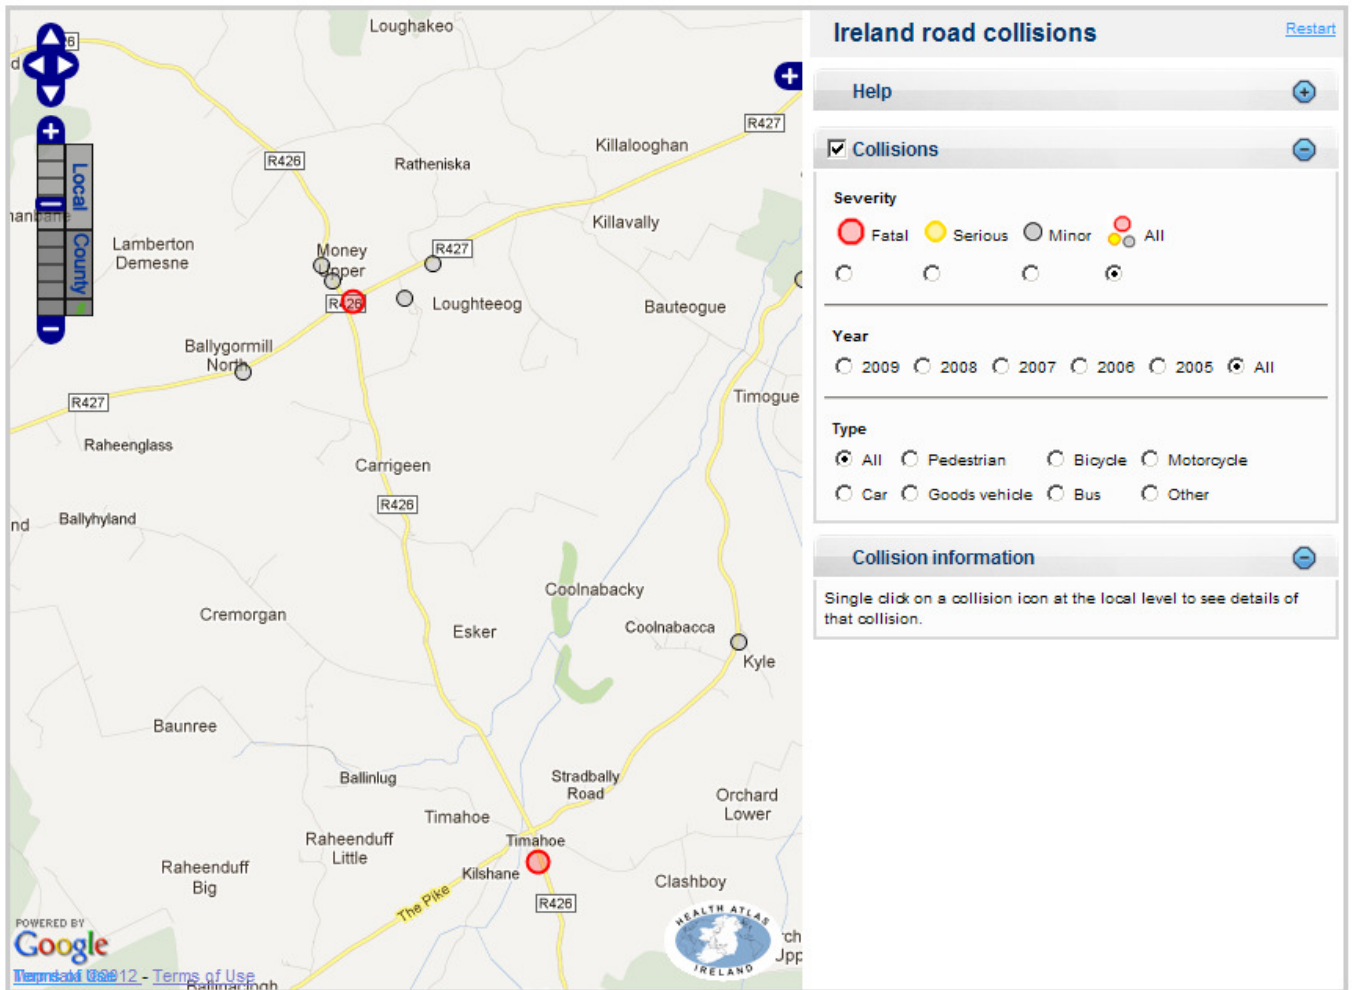
- The Road Safety Authority database of personal injury accidents was interrogated to establish if there are any existing safety issues in the vicinity of the development that are not evident from the site visit. The period of accident data examined is from 2005-2009.
- The records indicate that there were no accidents in the vicinity of the proposed works.

Figure-2: RSA Accident Records (2005-2009) in vicinity of proposed scheme (www.RSA.ie)

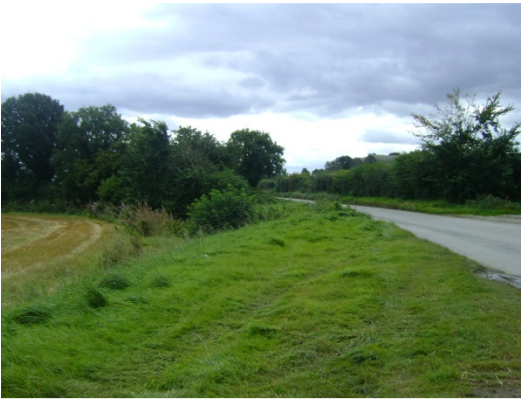
<b>4.2.1 Problem</b>

<i>Location:</i>	Proposed Access Road	
<i>Drawing:</i>	60241205-001	
<i>Summary:</i>	Visibility to the south	
<i>Description:</i>		
<p>Visibility to the south (left), from an approximate 3m setback for drivers exiting the site access road is restricted due to the alignment of the R426 road and trees/vegetation. This may lead to vehicles encroaching into the carriageway to achieve adequate visibility resulting in side-impact collisions and/or head on collisions as a result of vehicles on the R426 swerving to avoid exiting vehicles.</p>		
<b>Recommendation:</b>		
<p>Provide adequate visibility for vehicles exiting the access road. This should take account of the speeds on the R426. Guidance is available in the Design Manual for Roads and Bridges.</p>

4.2.1	Yes	Yes/No	It is proposed to remove vegetation within the verge area to the south of the proposed access within the extents of the lands in the control of the applicant, to improve visibility. In terms of overall visibility requirements for the road type and vehicle speeds recorded/observed, the Design Team were advised by Laois County Council Roads Department that given the proposed access represents an improvement on the existing access, and that the likely trips generated by the proposed development during operation are marginal compared to current usage, the Authority would not see any significant safety issues arising from such a proposal.

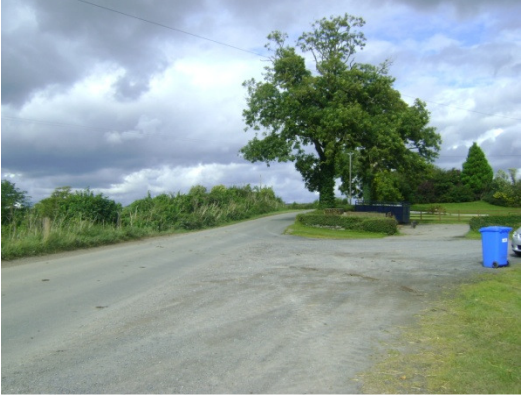
<b>4.2.2 Problem</b>

<i>Location:</i>	Proposed Site Access Road	
<i>Drawing:</i>	60241205-001	
<i>Summary:</i>	Visibility to north	
<i>Description:</i>		
<p>Visibility to the north (right) from an approximate 3m setback for drivers exiting from the access road is restricted due to a single large tree located along the R426. This may lead to vehicles encroaching into the carriageway to achieve adequate visibility resulting in side-impact collisions and/or head on collisions as a result of vehicles on the R426 swerving to avoid exiting vehicles.</p>		
<b>Recommendation:</b>		
<p>Provide adequate visibility for vehicles exiting the substation access. This should take account of the speeds on the R426. Guidance is available in the Design Manual for Roads and Bridges. This could be achieved by removing the large tree.</p>

4.2.2	Yes	Yes	It is proposed to remove the tree located immediately to the north of the existing access on the east side of the R426.
4.2.3	No	No	The proposed access has a 10m radius on both the north and south edge lines entering the road from the R426, in accordance with para.7.27 of NRA DMRB TD41-42/11. During normal operations only light vehicle/van access is expected to the proposed substation and typical existing farm access movements to and from the R426 would relate to a tractor and trailer unit, for which the 10m radius is suitable. In the unlikely event of a larger vehicle being required to access the substation for maintenance reasons, appropriate measures such as banksmen and temporary signage will be implemented on the R426 during movements to/from the site.

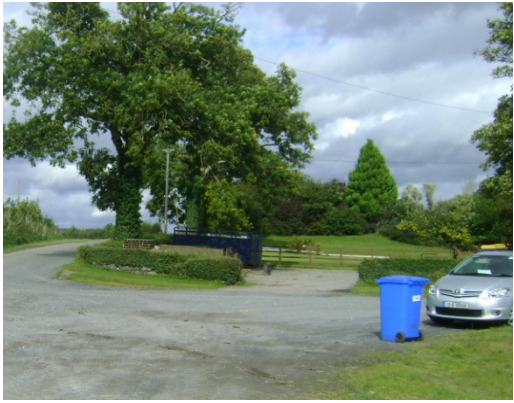
<b>4.2.4 Problem</b>

<i>Location:</i>	Existing Farm Yard Access	
<i>Drawing:</i>	60241205-001	
<i>Summary:</i>	No details provided	
<i>Description:</i>		
<p>Access is currently provided to a farm yard, located on the existing access road, approximately 10m from the R426 road edge. The proposed scheme plans to realign the access road, by moving it approximately 20m south. No details have been provided regarding arrangements for the farm access.</p> <p>Failure to provide an appropriate access arrangement for vehicles entering and existing the farm yard may bring these vehicles into conflict with vehicles on the access road/R426, thus increase the risk of collision.</p>		
<b>Recommendation:</b>		
Details of the access arrangements for the farm yard should be provided prior to construction.

4.2.4	No	No	It is proposed that the existing access to the dwelling/yard will be retained, in accordance with the requirements of the landowner, but it will be separated from the proposed access road by an appropriate boundary treatment. Both the existing access and the proposed new access have good visibility of each other, and having regard for the low volumes generated, no conflict or interaction is expected.
