## **Appendix 11.5 AECOM Transportation: Road Safety Audit - Ballyragget**

# ESB Site Access Ballyragget – Stage 1/2 Road Safety Audit

Job No 60273241

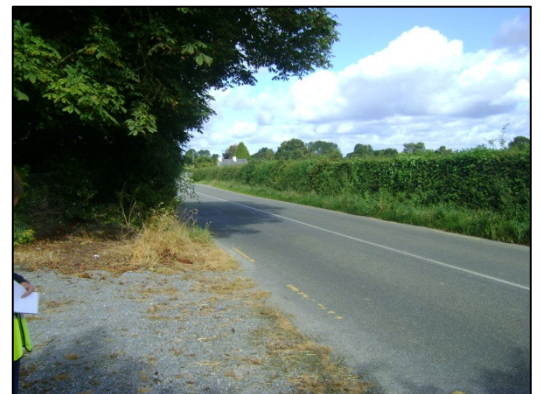
- The road is approximately 5.5m wide in the vicinity of the site, and runs in a north south direction. There is a small dip on the approach from the south to the substation, with the road levelling off as it passes the access points.
- There is good forward visibility to the site access from the south, with in excess of 150m visibility provided, while the road heading north bends slightly to the east approximately 150m from the site access.
- There is a solid white line on the R432, fronting the site, while the dashed yellow lines are well worn and barely visible in parts.

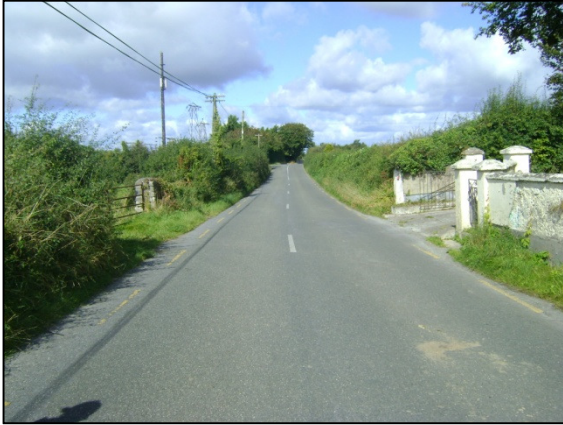
*Photo 1: R432 looking north towards site access*

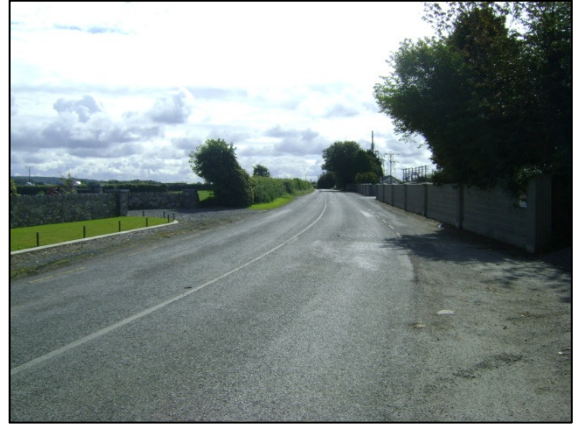
*Photo 2: R432 looking south towards site access, with Cemetery visible*

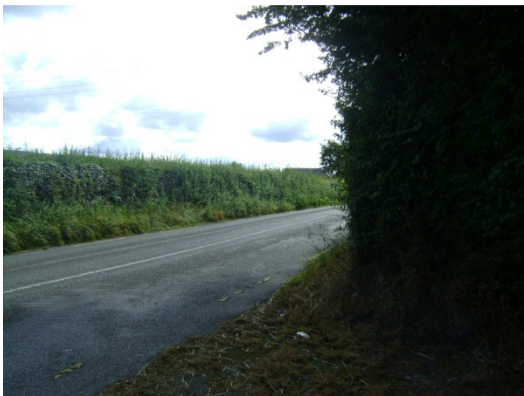
<b>4.2.1 Problem</b>

<i>Location:</i>	Proposed Site Access	
<i>Drawing:</i>	60273241-002	
<i>Summary:</i>	Visibility to the south	
<i>Description:</i>		
<p>Visibility to the south (right), from an approximate 3m setback for drivers exiting from the site access is restricted due to trees/fence located along the R432. This may lead to vehicles encroaching into the carriageway to achieve adequate visibility resulting in side-impact collisions and/or head on collisions as a result of vehicles on the R432 swerving to avoid exiting vehicles.</p>		
<b>Recommendation:</b>		
<p>Provide adequate visibility for vehicles exiting the substation access. This should take account of the speeds on the R432. Guidance is available in the Design Manual for Roads and Bridges. This could be achieved by removing/cutting back on vegetation, as well as repositioning of the fence line. A maintenance plan is required to ensure that this trimming and cutting back is carried out at regular intervals to ensure adequate visibility is maintained.</p>

4.2.1	Yes	Yes	The existing screen planting vegetation to the south of the proposed access location within the site frontage is to be removed and the boundary fence is to be located behind the sightline to improve visibility, as shown on the amended drawing 60272341_002 'Site Access Proposed Improvements'.

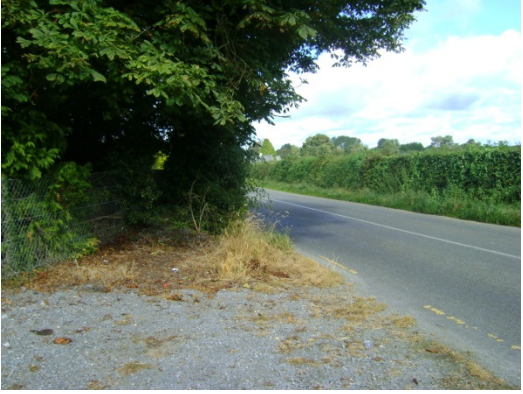
<b>4.2.2 Problem</b>

<i>Location:</i>	Proposed Site Access	
<i>Drawing:</i>	60273241-002	
<i>Summary:</i>	Visibility to north	
<i>Description:</i>		
<p>Visibility to the north (left), from an approximate 3m setback for drivers exiting from the site access is restricted due to trees located along the R432. This may lead to vehicles encroaching into the carriageway to achieve adequate visibility resulting in side-impact collisions and/or head on collisions as a result of vehicles on the R432 swerving to avoid exiting vehicles.</p>		
<b>Recommendation:</b>		
<p>Provide adequate visibility for vehicles exiting the substation access. This should take account of the speeds on the R432. Guidance is available in the Design Manual for Roads and Bridges. This could be achieved by removing/cutting back on vegetation. A maintenance plan is required to ensure that this trimming and cutting back is carried out at regular intervals to ensure adequate visibility is maintained.</p>

4.2.2	Yes	Yes	The vegetation and boundary features which are in the ownership of the applicant to the north of the northern access location are to be removed to ensure to improve the sightline for visibility to the north, as shown on the amended drawing 60272341_002 'Site Access Proposed Improvements'.

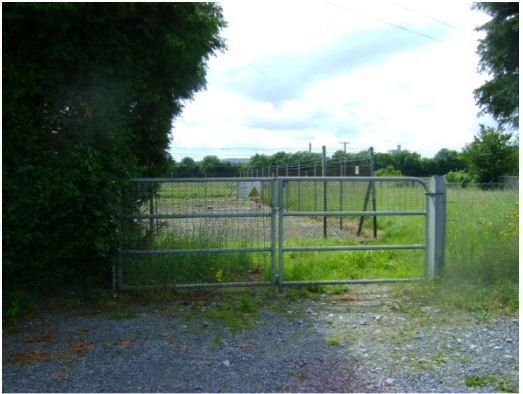
<b>4.2.3 Problem</b>

<i>Location:</i>	Proposed Site Access	
<i>Drawing:</i>	60273241-002	
<i>Summary:</i>	Turning Movements	
<i>Description:</i>		
<p>It is expected that large vehicles will access the site on occasion. No autotracks have been provided to show that these large vehicles are capable of making this movement. Failure to provide adequate space for these vehicles to make the turning movement may increase the risk of collision with vehicles already on the R432.</p>		
<b>Recommendation:</b>		
<p>Ensure all turning radii are designed to allow appropriate HGV movements. These should be reviewed prior to construction.</p>

4.2.3	No	No	The access gate is currently set back within the site and is therefore not to be relocated, and is in accordance with Fig 7/5 of NRA DMRB TD41-42/11. During normal operations only light vehicle/van access is expected to the upgraded substation. In the unlikely event of a larger vehicle being required to access the substation for maintenance reasons, appropriate measures such as banksmen and temporary signage will be implemented on the R432 during movements to/from the site.

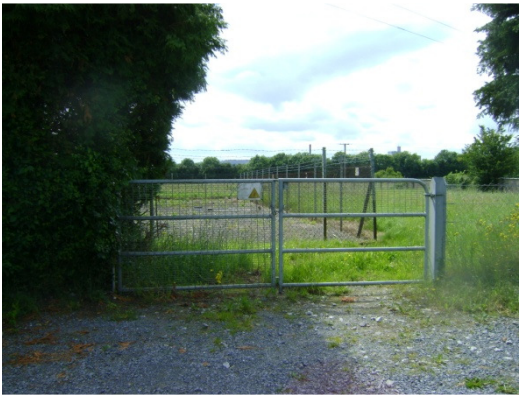
<b>4.2.4 Problem</b>

<i>Location:</i>	Proposed Site Access	
<i>Drawing:</i>	60273241-002	
<i>Summary:</i>	Access control	
<i>Description:</i>		
<p>It is not clear from the drawing if a gated access will be provided to the proposed development. Access to the existing substation is restricted with gates, set back from the carriageway. Should gates be provided close to the road edge, visitors to the facility will be forced to park on the road, while opening/closing the gates. This would increase the conflict between parked cars and passing motorists, thus increasing the risk of collision.</p>		
<b>Recommendation:</b>		
<p>Clarify the proposals for the access control. Provision should be made to allow a vehicle pull in off the road and access the gates in a safe manner, similar to the existing situation.</p>

4.2.4	Yes	Yes	The gates are inward opening and are set back from the road edge as illustrated on the drawing 60272341_002 'Site Access Proposed Improvements' appended to this response. This allows adequate space for a van to be positioned fully off the road while the gate is being opened or closed.

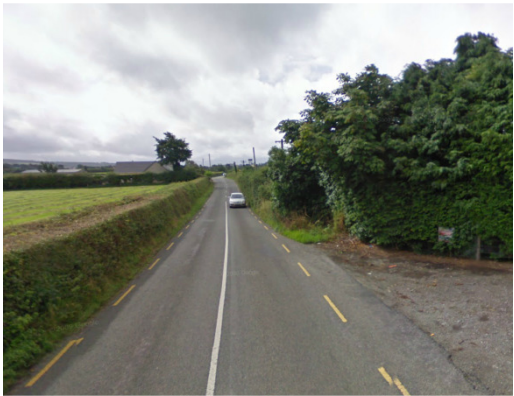
<b>4.2.5 Comment</b>

<i>Location:</i>	Existing Southern Site Access	
<i>Drawing:</i>	60273241-002	
<i>Summary:</i>	Clarification for Southern Access	
<i>Description:</i>		
<p>It is not clear from the drawings if the existing southern access is to be extinguished or maintained. Similar to the northern access, foliage infringes on sight lines for vehicles exiting at this point. This may lead to vehicles encroaching into the carriageway to achieve adequate visibility resulting in side-impact collisions and/or head on collisions as a result of vehicles on the R432 swerving to avoid exiting vehicles.</p>		
<b>Recommendation:</b>		
<p>Clarify the proposals for the southern access. Similar to the problems above, adequate visibility must be provided if the access is to be maintained. This should take account of the speeds on the R432. Guidance is available in the Design Manual for Roads and Bridges. A maintenance plan may need to be put in place to ensure regular trimming and cutting back occurs.</p>

4.2.5	No	No	It not proposed that the existing southern access will be removed as part of this development. The southern access currently provides access for ESB Telecoms to the communications compound located inside the southern gate and for this reason it is planned to be maintained. The new development associated with this planning submission (110kV Substation) will be accessed solely by the northern gate which is to be improved by providing the required sightlines as part of this development. It is noted that the screen planting vegetation and boundary fence along the site frontage (to the north of the existing southern access) is to be removed and relocated to the rear of the northern access sightline as part of the improvement works to the northern access and this will provide a positive secondary benefit and an improvement on the existing conditions for the existing southern access, as illustrated on drawing 60272341_002 'Site Access Proposed Improvements'.
