## **Appendix 11.6 AECOM Transportation: Haulage Route Assessment**

# EirGrid 400/110kV Transformer; Proposed Haulage Route Assessment

Job No 60241205

Date Created March 2012

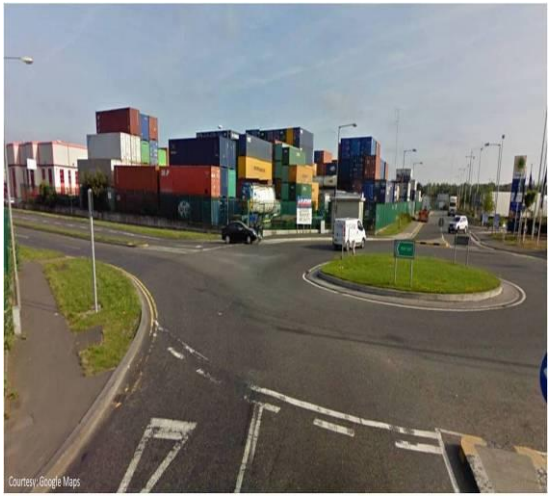
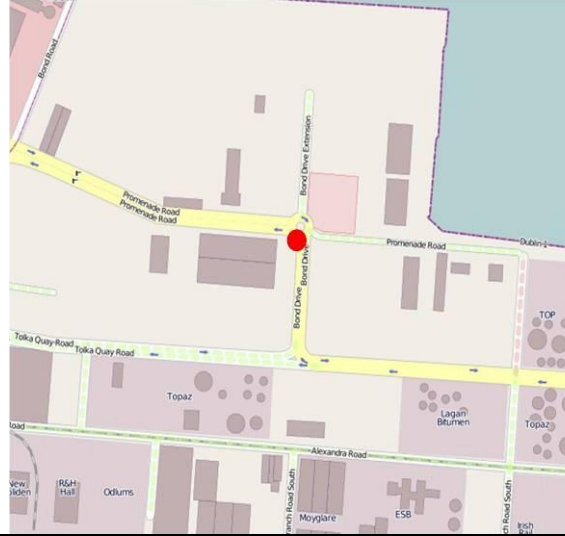
#### Issue 2.1.1

<b>Possible Issue or Hazard</b>	Turning left at roundabout
<b>Remedial Action</b>	Carry out Autotrack sweptpath analysis on junction prior to journey being undertaken. Two lane entry and exit widths should ensure junction is negotiated successfully.

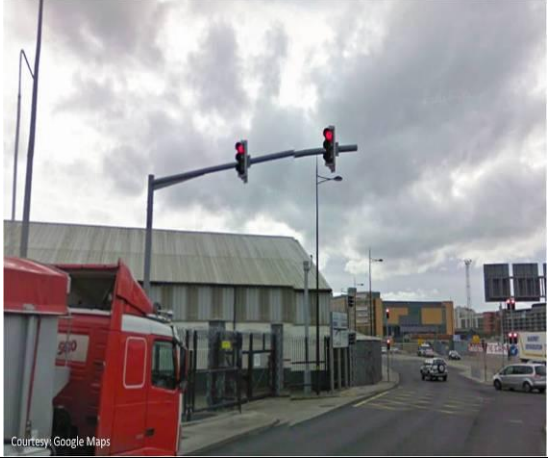
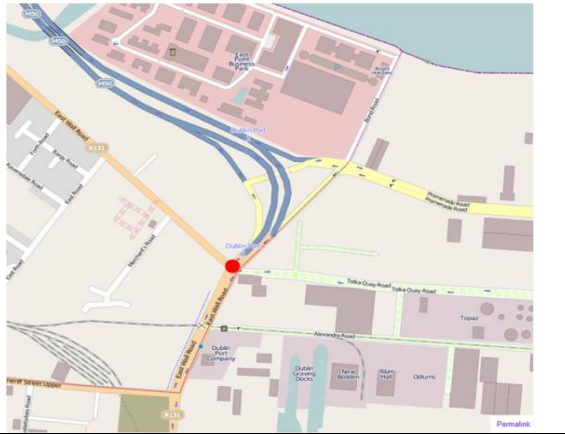
#### Issue 2.1.2

<b>Possible Issue or Hazard</b>	Signal heads mounted on overhead gantry pole.
<b>Remedial Action</b>	Overhead clearance should not be an issue here, however care should be taken when approaching signals nonetheless. If possible, right lane only to be used as signal pole crosses most of the two inside lanes.

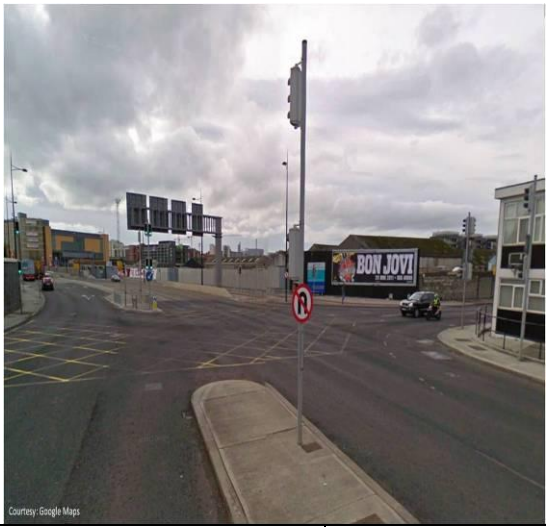
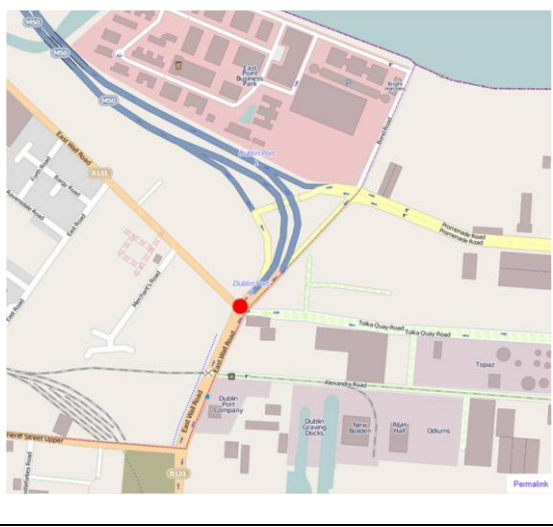
#### Issue 2.1.3

<b>Possible Issue or Hazard</b>	Turning right onto East Wall Road
<b>Remedial Action</b>	Carry out Autotrack sweptpath analysis on junction prior to journey being undertaken. If required there is scope to mount the traffic island in the foreground of the above image though this should not be necessary.

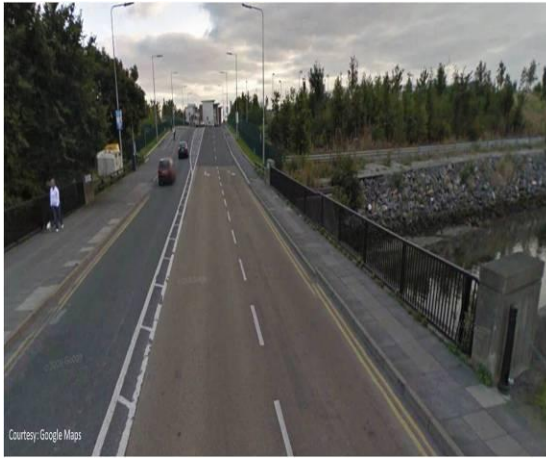
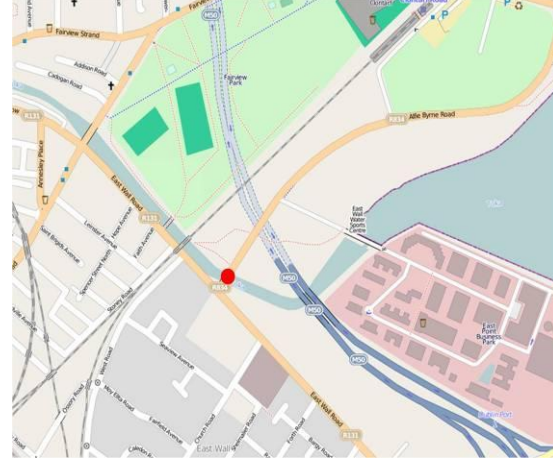
Issue 2.1.4

<b>Possible Issue or Hazard</b>	Structural integrity of McCormack Bridge over Tolka River.
<b>Remedial Action</b>	Up to date structural assessment of Tolka River Bridge may be required prior to journey being undertaken.

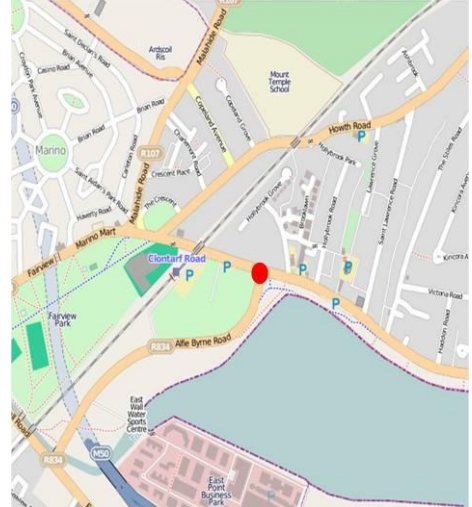
Issue 2.1.5

<b>Possible Issue or Hazard</b>	Turning right at onto Clontarf Road.
<b>Remedial Action</b>	Carry out Autotrack sweptpath analysis on junction prior to journey being undertaken. Temporary removal of two lit traffic bollards on central traffic island will facilitate overrun of said island, thereby increasing junction turning radius.

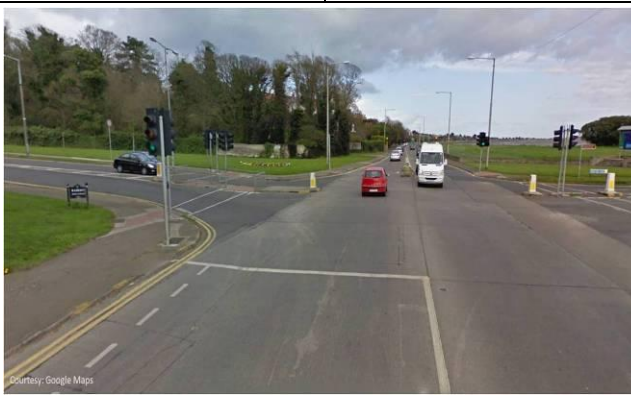
Issue 2.1.6

<b>Possible Issue or Hazard</b>	Turning left onto Watermill Road.
<b>Remedial Action</b>	Carry out Autotrack sweptpath analysis on junction prior to journey being undertaken. Manoeuvre made easier as there is no central island on the Clontarf Rd approaching arm.

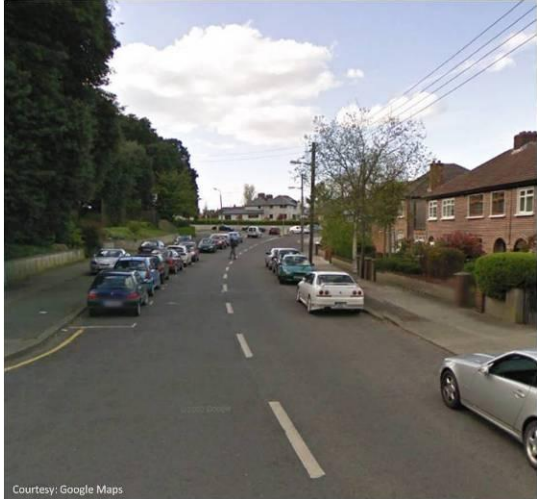
Issue 2.1.7

<b>Possible Issue or Hazard</b>	Parked cars along Watermill Road.
<b>Remedial Action</b>	Care to be taken along this section of Watermill Road due to car parking on both sides of road. If possible, liaise with local authority (Dublin City Council) prior to undertaking journey and request a restriction on car parking at time of transportation.

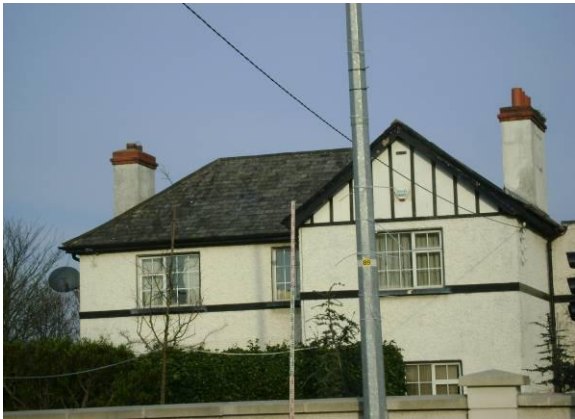
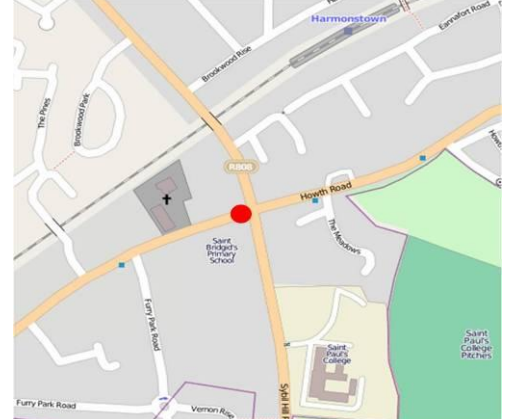
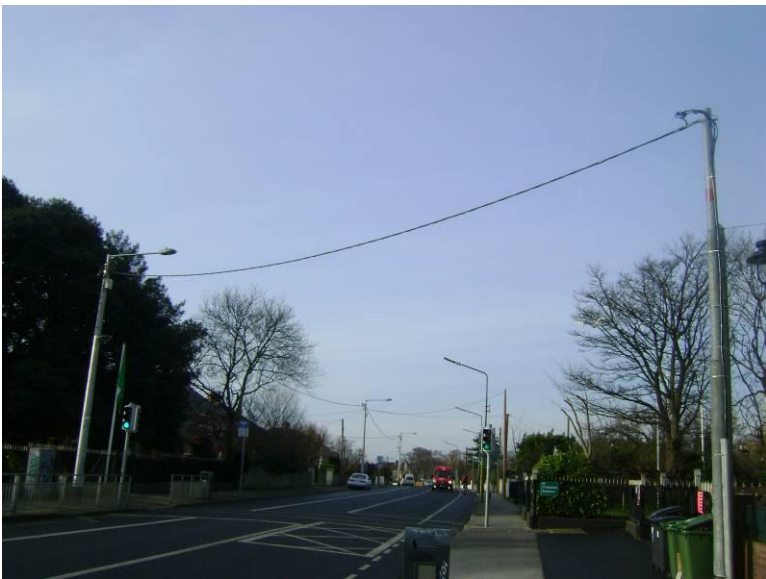
Issue 2.1.9

<b>Possible Issue or Hazard</b>	Overhead wires.
<b>Remedial Action</b>	Fully extended 3.9m surveying staff is shown in above image for scale. There appears to be sufficient clearance for transformer, bearing in mind that the trailer of the transportation unit can be lowered if necessary, but care should be exercised as there are numerous instances of low overhead wires along this residential part of Howth Road between the co-ordinates mentioned above. Another example of these overhanging wires is shown below in Photo 2.1.
<i>Photo 2.1: Overhead Wires on Howth Road between Sybill Hill and Collins Avenue junctions</i>

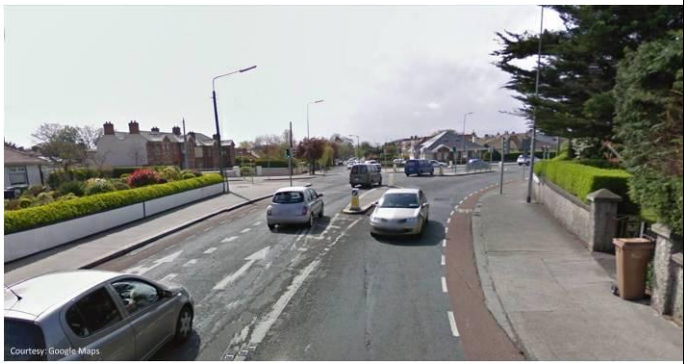
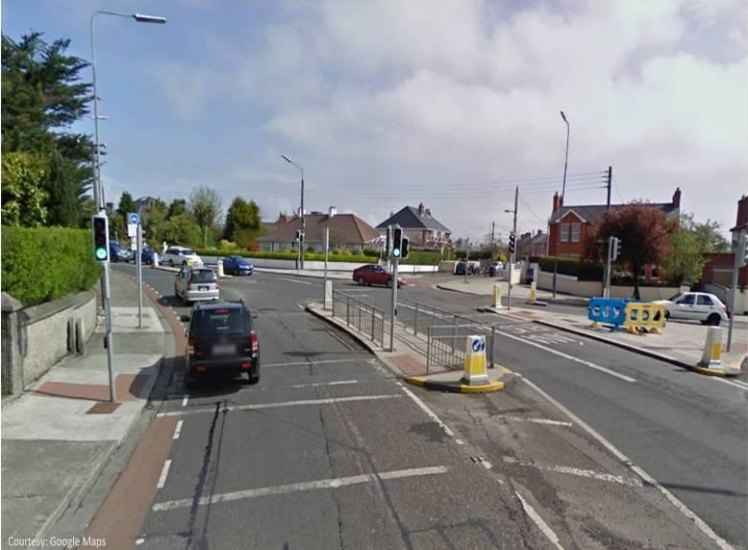
Issue 2.1.10

<b>Possible Issue or Hazard</b>	Narrow approach and central refuge island with pedestrian guard rails upon exit.
<b>Remedial Action</b>	Carry out Autotrack sweptpath analysis on junction prior to journey being undertaken. Remove lit traffic bollards on central island on entry of bend to facilitate overrun of island if necessary. Photo 2.2 below shows the junction from the reverse angle and displays a relatively wide exit through the junction which is facilitated by the presence of a bus lane.
<i>Photo 2.2: Howth Road / Dunluce Road junction looking northeast</i>

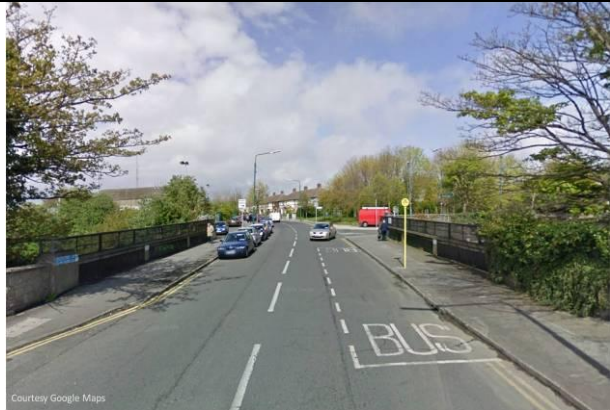
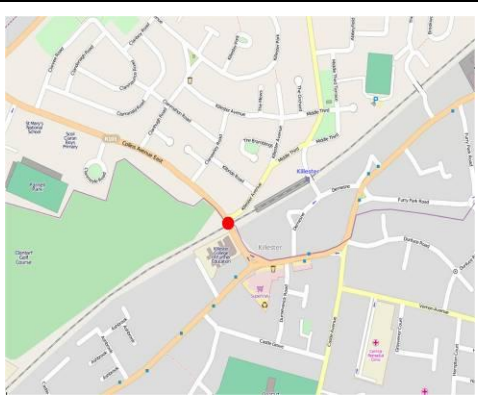
Issue 2.1.12

<b>Possible Issue or Hazard</b>	Structural integrity of railway overbridge (OBB9A) Dublin – Belfast line
<b>Remedial Action</b>	Irish Rail to check structural integrity of railway overbridge

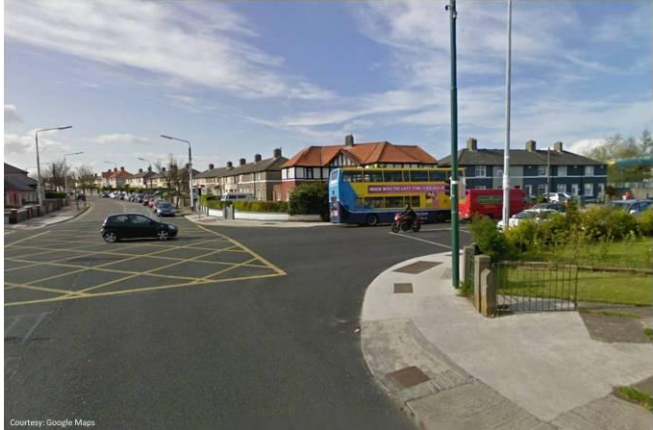
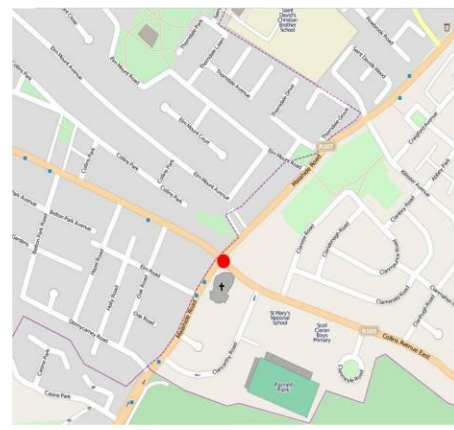
Issue 2.1.14

<b>Possible Issue or Hazard</b>	Turning right onto R107 Malahide Road	
<b>Remedial Action</b>	Carry out Autotrack sweptpath analysis on junction prior to journey being undertaken. There is good scope for successful negotiation of this junction. As it can be seen there is no central island or obstruction upon entry to the Malahide Road and also there is no obstruction upon exiting Collins Avenue either. Best practice dictates however, that Autotrack sweptpath analysis be carried out nonetheless.

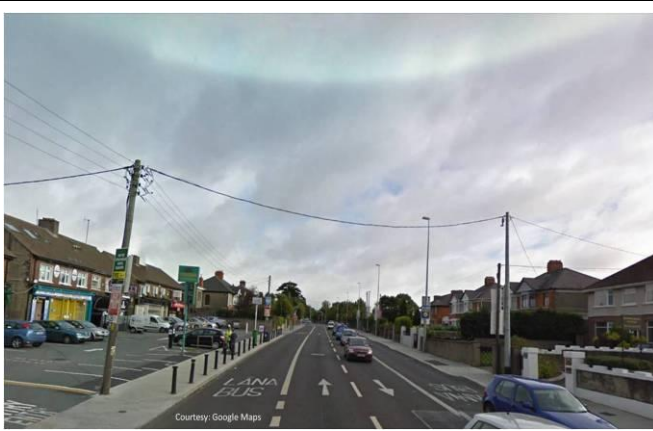
Issue 2.1.15

<b>Possible Issue or Hazard</b>	Overhead lines	
<b>Remedial Action</b>	Low hanging overhead lines. Lines are quite slack so it should not be an issue to lift them out of the way temporarily using poles as the transportation unit is passing beneath. Care should be exercised when passing this location nonetheless.

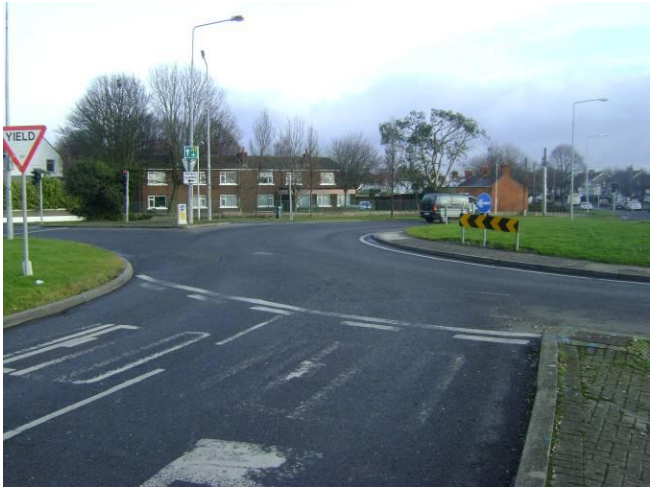
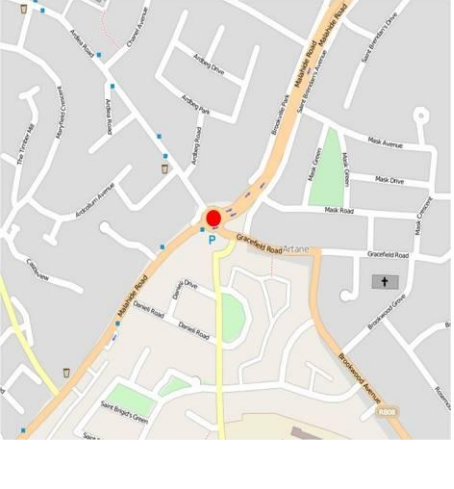
Issue 2.1.16

<b>Possible Issue or Hazard</b>	Artane Roundabout	
<b>Remedial Action</b>	<p>Carry out Autotrack sweptpath analysis on junction prior to journey being undertaken. The Artane roundabout is the first major roundabout encountered on the haulage route. The image above shows the northbound approach from which the transportation unit will be approaching. Entry width is good, however, the deflection angle upon entry means entirely avoiding the central island will probably not be possible. As the island is not particularly high or steeply banked on the sides the most prudent options would be lay down a track for the right hand side of the vehicle to travel along while the left hand side stays on the road. This method of crossing will require the temporary removal of three sets of chevron boards and three supplementary keep left signs. Photo 2.4 below shows a generous width on the circulating carriageway. Photo 2.5 shows the side profile of the central island (looking east) which should not be particularly difficult to cross with the transportation unit.</p>

*Photo 2.4: Looking north towards exit of Artane Roundabout*

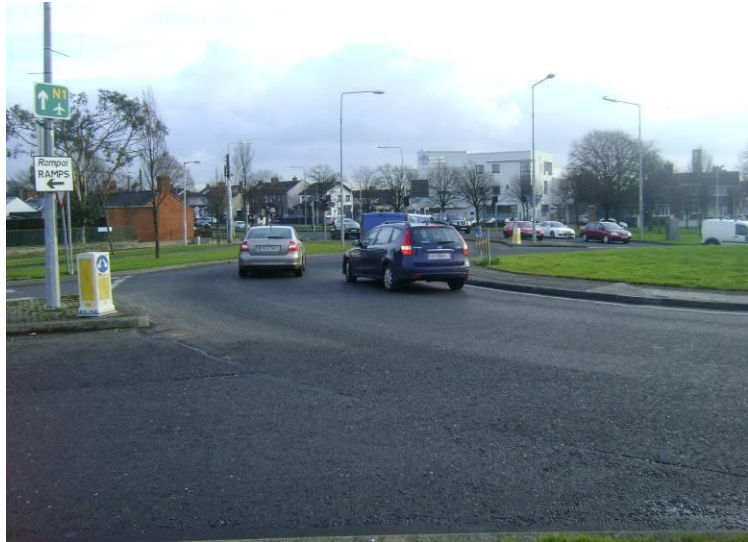
*Photo 2.5: Looking east across Artane Roundabout.*

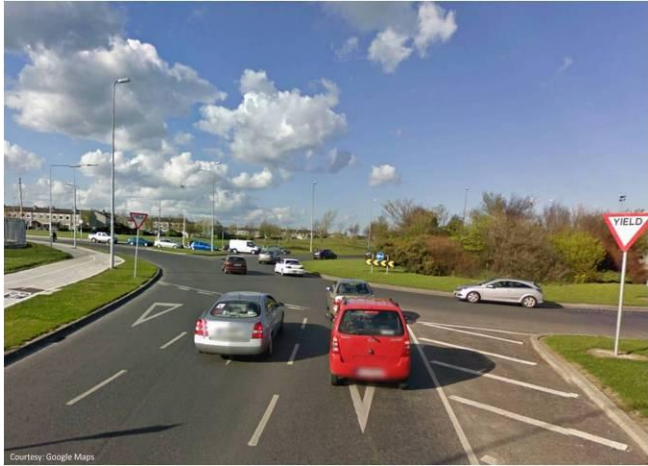
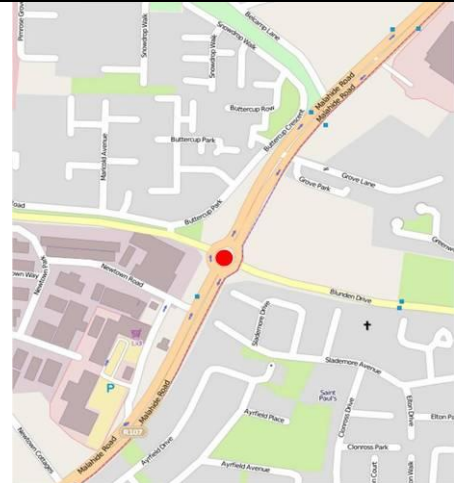
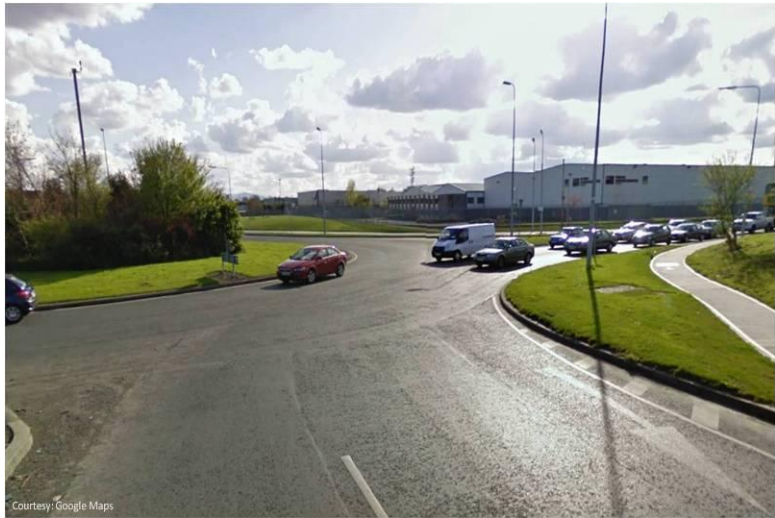
Issue 2.1.17

<b>Possible Issue or Hazard</b>	Darndale Roundabout	
<b>Remedial Action</b>	<p>Carry out Autotrack sweptpath analysis on junction prior to journey being undertaken. The Darndale Roundabout is the second major roundabout encountered along the Malahide Road. It has an extremely wide approach and allied to this the relatively low deflection angle upon entry and three lane circulating carriageway mean that this roundabout may be negotiated without the need to impinge on the central island. Photo 2.6 below shows the exit of the roundabout looking south, it can be seen that the roundabout is also dual carriageway upon exit.</p>	
<p><i>Photo 2.6: Looking south from northbound exit</i></p>

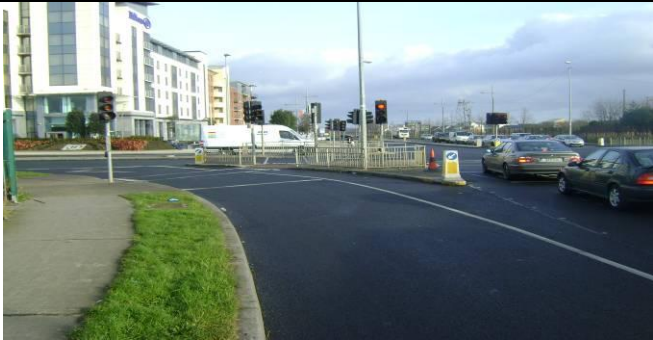
Issue 2.1.19

<b>Possible Issue or Hazard</b>	Turning left off Malahide Road onto R139.	
<b>Remedial Action</b>	Carry out Autotrack sweptpath analysis on junction prior to journey being undertaken. The left turn filter lane here is quite wide and as such may facilitate the passing of the transportation unit. The transportation unit will use the outermost lanes on the northbound approach and aim to approach the filter lane in as straight a formation as possible. After passing through here the median between the eastbound / westbound carriageways on the R139 may be mounted to allow the transportation unit to straighten and continue along the R139 westbound. If this approach does not work, an alternative method of negotiating the junction may be to approach on the outermost lane of the northbound carriageway and in order to increase the turning radius of the corner, exit on the eastbound carriageway of the R139 before mounting the median further down to return to the westbound carriageway of the R139, see Figure 2.1 below. Autotrack sweptpath analysis of the junction will determine which method is most likely to be used.

*Photo 2.7: Looking east  
along R139 towards exit of  
Clarehall Junction*

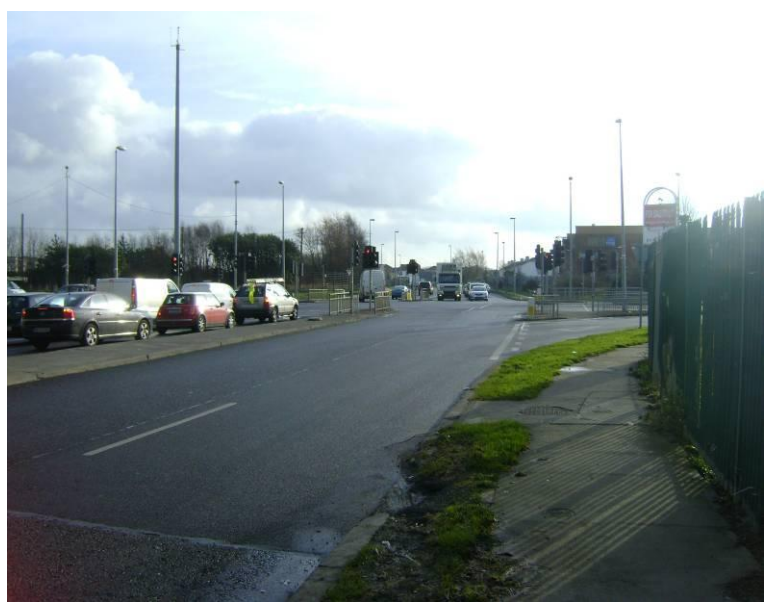
*Figure 2.1: Alternative  
option to negotiating R139 /  
R107 junction*

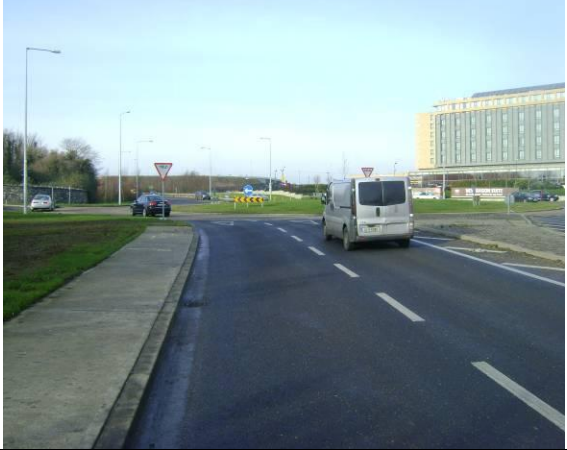
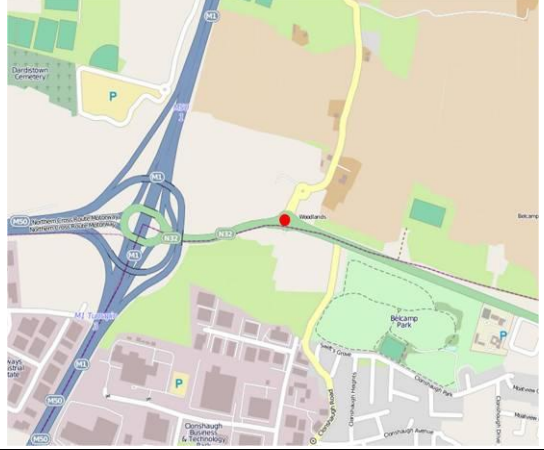
Issue 2.1.20

<b>Possible Issue or Hazard</b>	R139 Roundabout at Bewleys Hotel	
<b>Remedial Action</b>	<p>Carry out Autotrack sweptpath analysis on junction prior to journey being undertaken. The Roundabout at the Bewleys Hotel is the last major roundabout encountered on Section1 of the route. Similar to the Darndale Roundabout, it has a low deflection angle upon entry and exit and hence facilitates relatively easy access to and exit from the roundabout. The entry, exit and circulating carriageway are all two lanes in width (see Photos 2.8 and 2.9 below). It can also be seen in Photo 2.8 below that there is an overrun strip running along the inside edge of the central island which will facilitate the mounting of the island if necessary. If this is required it will also require the temporary removal of two chevron boards and two keep left signs. Autotrack sweptpath analysis of the junction will establish if this is necessary.</p>

<p><i>Photo 2.8: Two lanes on circulating carriageway</i></p>

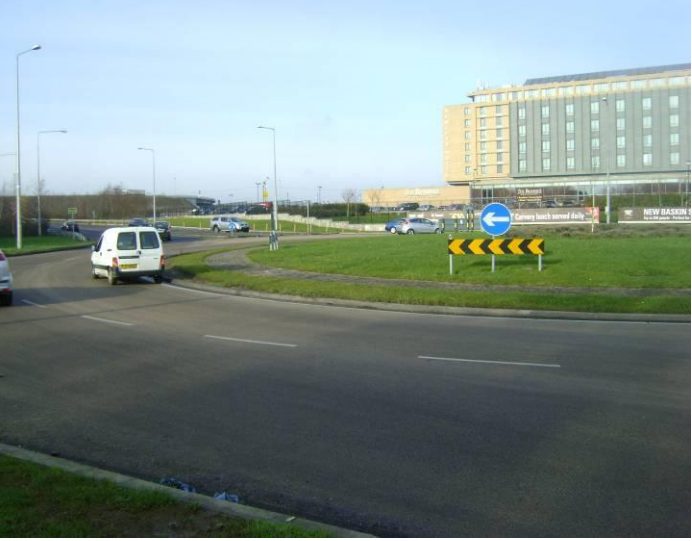
*Photo 2.9: Looking south  
upon exit of Bewleys  
Roundabout*

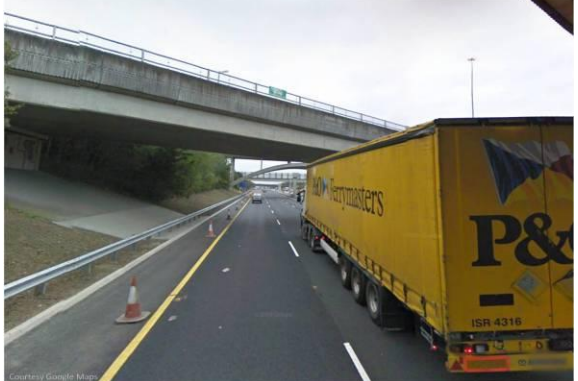
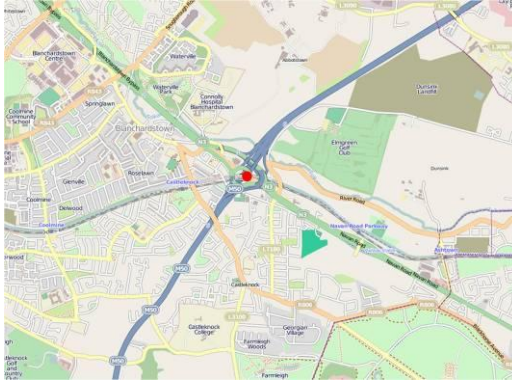
*Issue 2.2.1*

<b>Possible Issue or Hazard</b>	Overhead clearance
<b>Remedial Action</b>	Vertical overhead clearance here is approximately 6m so it should not be an issue, however it is advised that care is taken on approach nonetheless.

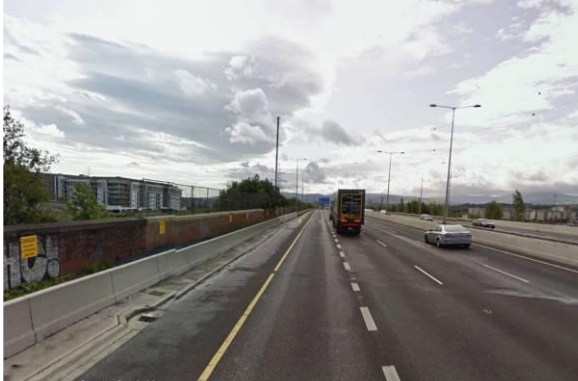
*Issue 2.2.2*

<b>Possible Issue or Hazard</b>	Structural integrity of railway overbridge (OBC10A) Dublin – Cork line
<b>Remedial Action</b>	Irish Rail require structural integrity of railway overbridge to be confirmed via an independent structural assessment.

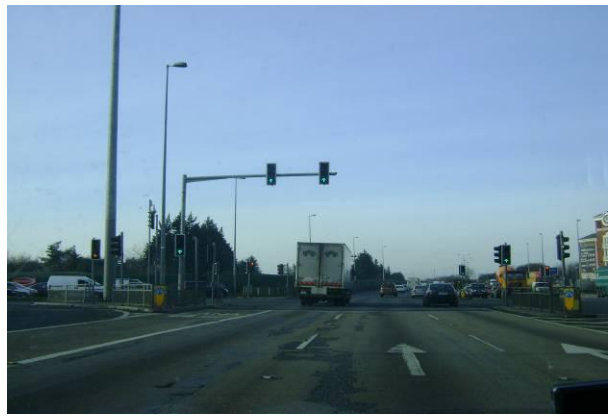
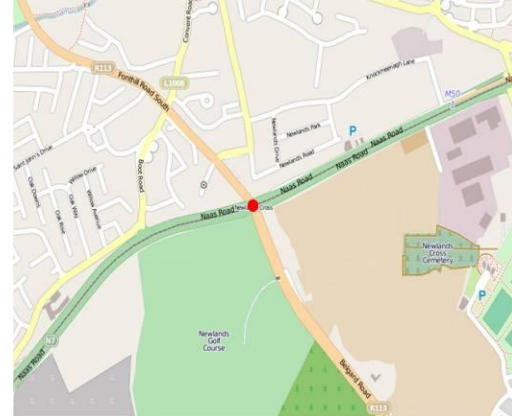
Issue 2.2.5

<b>Possible Issue or Hazard</b>	Overhead signal heads.
<b>Remedial Action</b>	Overhead clearance should not be an issue here but care should be exercised and the two outside lanes of the carriageway should be straddled to avoid conflict.

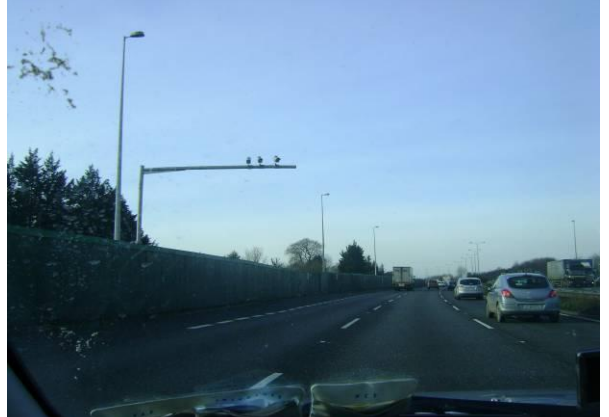
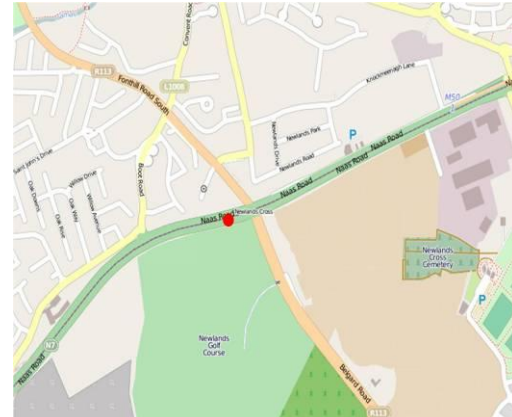
Issue 2.2.6

<b>Possible Issue or Hazard</b>	Overhead traffic monitoring cameras
<b>Remedial Action</b>	Use of the inside lane to be avoided here to prevent possible conflict with overhead traffic monitoring cameras.

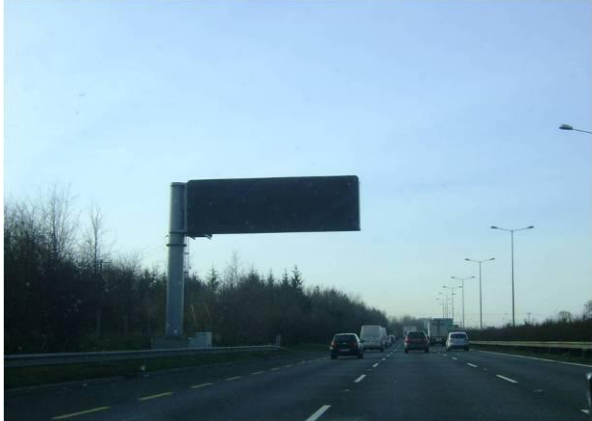
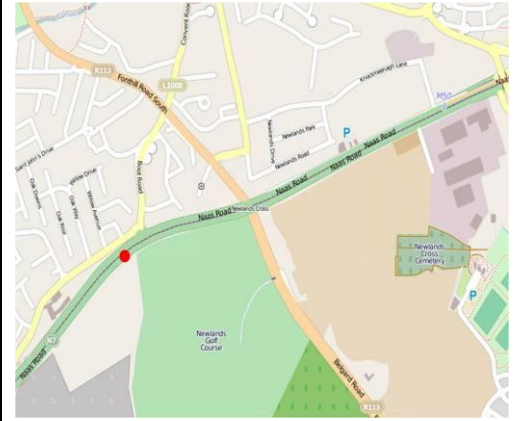
Issue 2.2.7

<b>Possible Issue or Hazard</b>	Overhead VMS sign
<b>Remedial Action</b>	Use of the inside lane to be avoided here to prevent possible conflict with overhead VMS sign

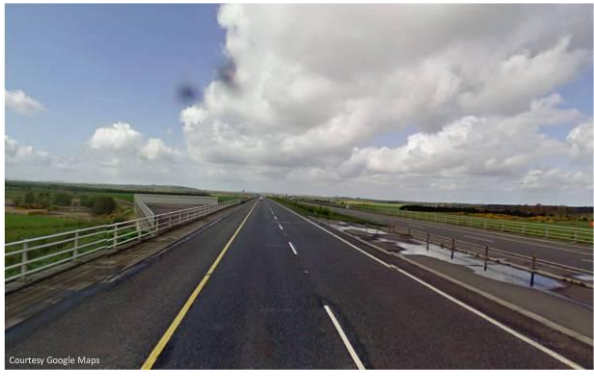
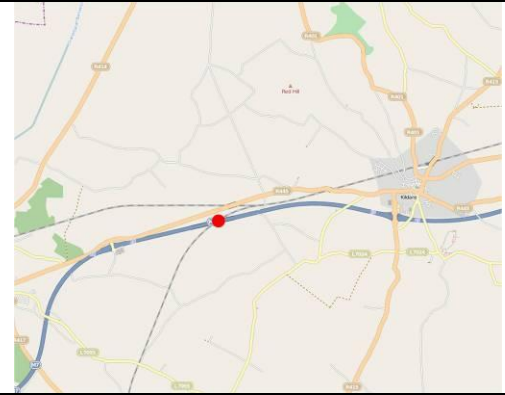
Issue 2.2.9

<b>Possible Issue or Hazard</b>	Structural integrity of railway overbridge (OBW2) – Carlow branch line near Cherryville	
<b>Remedial Action</b>	Irish Rail require structural integrity of railway overbridge to be confirmed via an independent structural assessment.

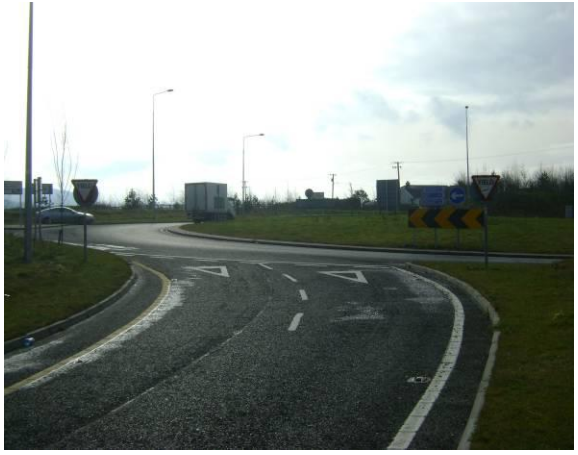
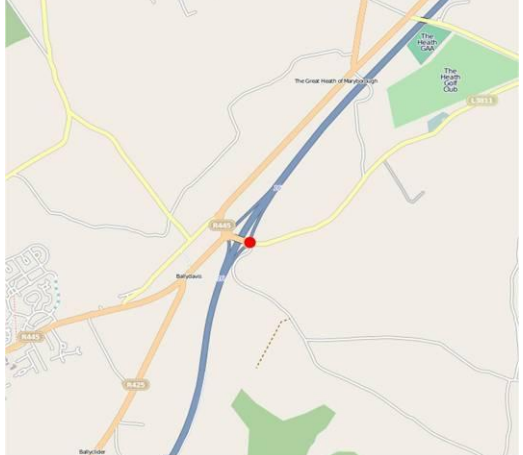
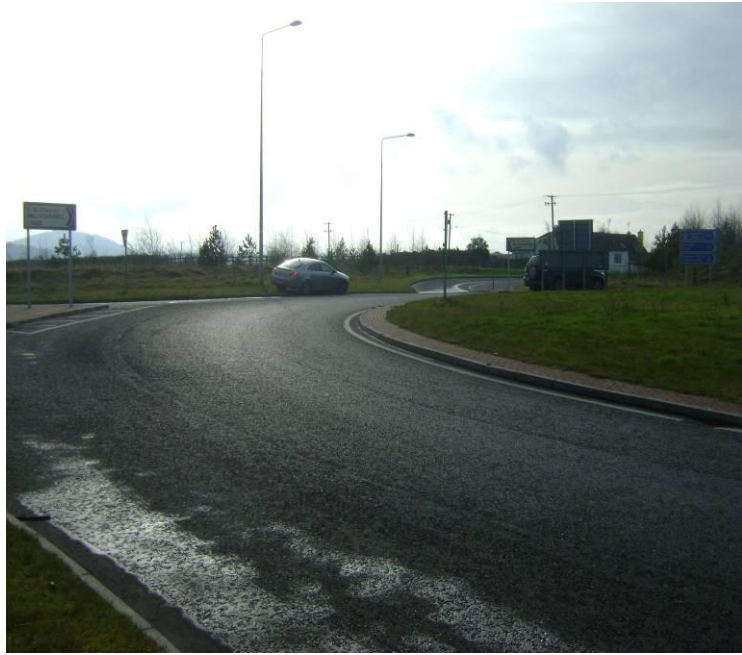
*Issue 2.3.1*

<b>Possible Issue or Hazard</b>	Roundabout at M7 Junction 16 interchange	
<b>Remedial Action</b>	<p>Carry out Autotrack sweptpath analysis on junction prior to journey being undertaken. Entry to junction is relatively wide at two lanes but it is required to turn right here to access the M7 overbridge and as such it is envisaged the central island will need to be mounted. Circulating carriageway widths are shown in photos 2.10 and 2.11 below. Photo 2.12 shows that the central island has a relatively flat profile and as such mounting should not be an issue when the necessary removal of two chevron boards and two keep left signs is facilitated. Autotrack analysis will show how much of the central island needs to be mounted to accommodate this manoeuvre.</p>

*Photo 2.10: Profile and circulating width of roundabout*

*Photo 2.11: Profile and circulating width of roundabout*

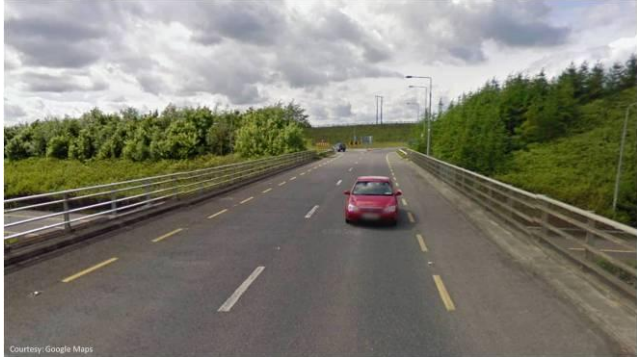
Issue 2.3.2

<b>Possible Issue or Hazard</b>	Structural integrity of M7 overbridge.	
<b>Remedial Action</b>	Possible structural integrity issues with M7 overbridge. A structural assessment may be required prior to transportation of transformer being undertaken to ensure it is structurally sound.

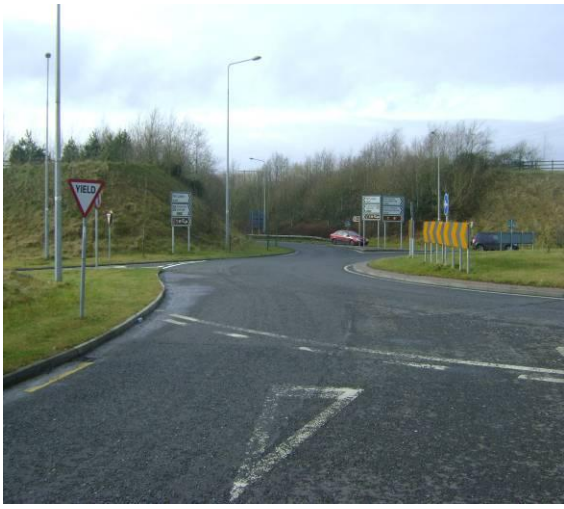
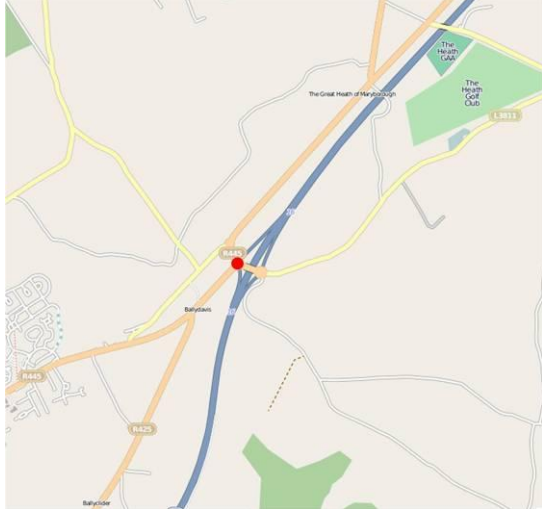
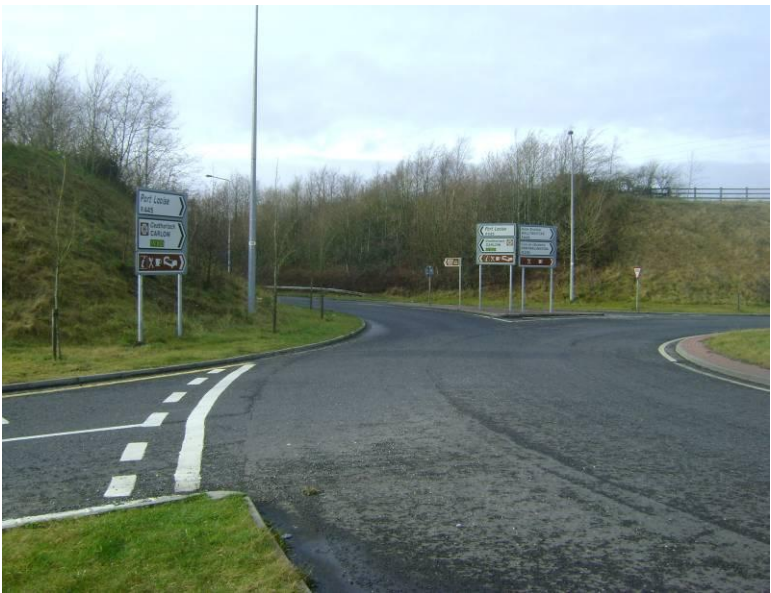
Issue 2.3.3

<b>Possible Issue or Hazard</b>	Roundabout at M7 Junction 16 interchange	
<b>Remedial Action</b>	Carry out Autotrack sweptpath analysis on junction prior to journey being undertaken. As can be seen above, the roundabout has a low entry angle and a two lane circulating carriageway which will facilitate easier access to the roundabout itself. The exit arm of the roundabout can be seen in Photo 2.13 below. The exit angle is sharper than the entry angle but the generous circulating width should accommodate the exit of the transportation unit without the need to overrun the central island upon entry. Autotrack analysis should be carried out here nonetheless.	
<p><i>Photo 2.13: View of exiting arm from roundabout at top of M7 northbound off-ramp</i></p>

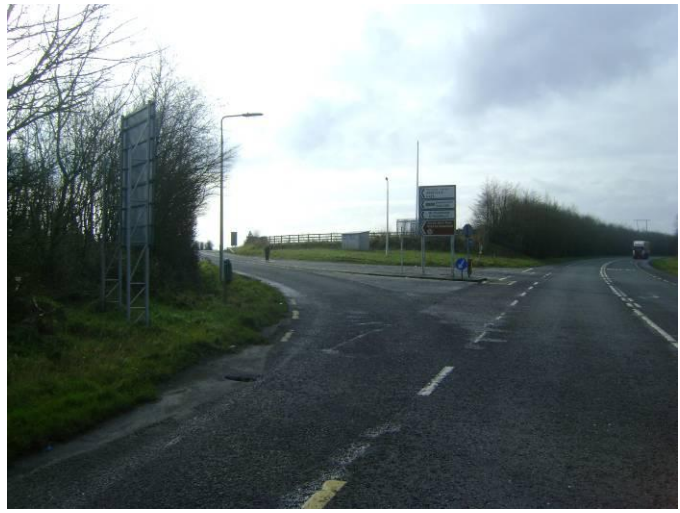
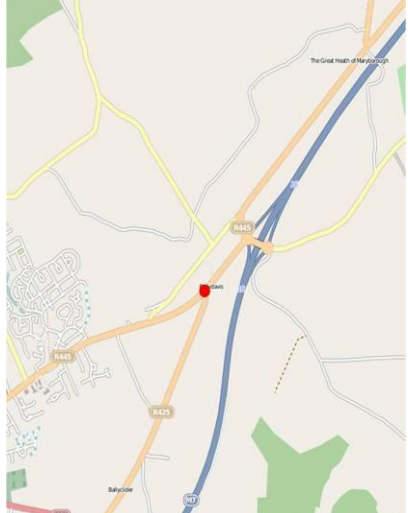
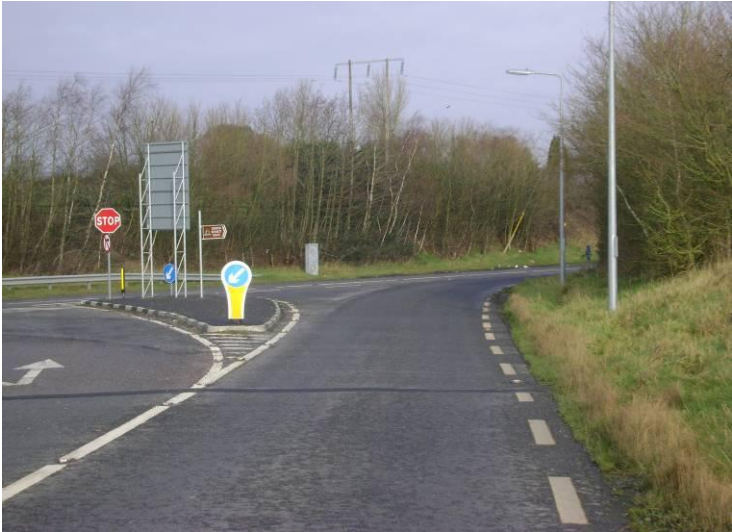
Issue 2.3.4

<b>Possible Issue or Hazard</b>	Turning left onto R425
<b>Remedial Action</b>	Carry out Autotrack sweptpath analysis on junction prior to journey being undertaken. The image above shows the R445 / R425 junction looking southwest from the R445. The junction has a relatively wide approach along the R445 and the turning radius is relatively large which means access should not be too difficult. It should be possible to negotiate this junction without mounting the central island, Autotrack sweptpath analysis will be necessary to confirm this however.
<i>Photo 2.14: Looking northeast towards the R445/R425 junction from the R425</i>

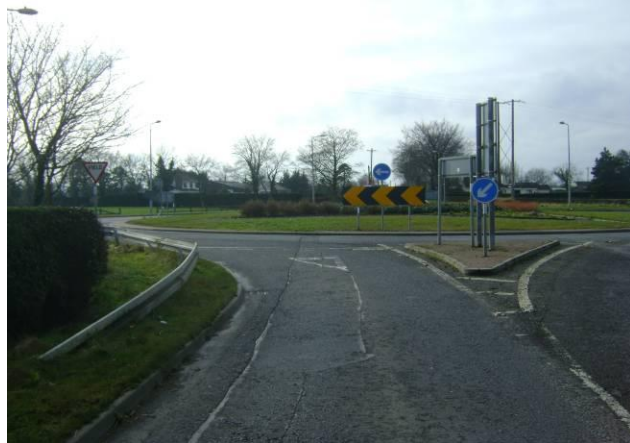
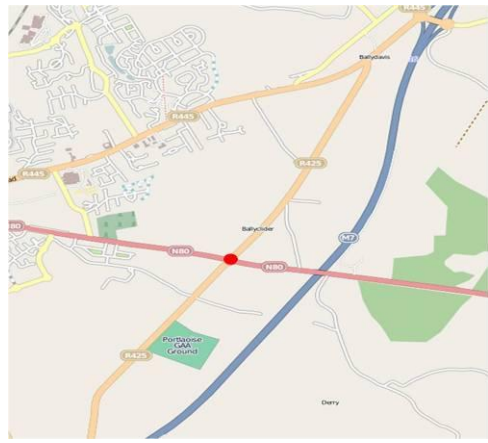
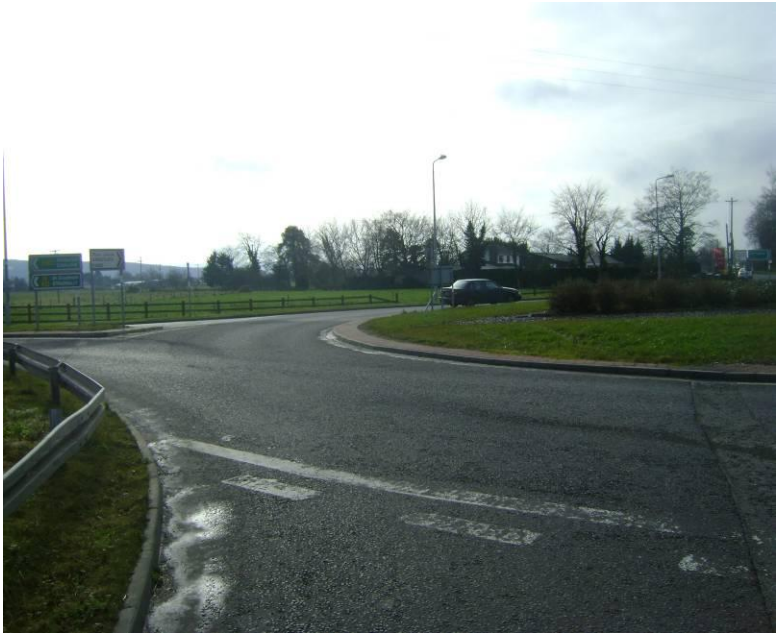
Issue 2.3.5

<b>Possible Issue or Hazard</b>	Roundabout at junction of R425 and N80
<b>Remedial Action</b>	Carry out Autotrack sweptpath analysis on junction prior to journey being undertaken. The above image shows the southbound approach to the R425 / N80 junction. It can be seen it is only a single lane approach and the deflection angle upon entry is higher than those encountered at previous roundabouts. It has a relatively wide circulating carriageway but is technically still one lane, see Photo 2.16 below. It is anticipated the central island will need to be mounted here to successfully negotiate the junction. Temporary removal of one set of chevron boards and keep left arrow will be required to facilitate this. Autotrack analysis will determine to what degree the island must be encroached upon.
<i>Photo 2.15: View of deflection upon entry to roundabout</i>

*Photo 2.16: Circulating  
carriageway width*

*Photo 2.17: Looking  
southwest towards R425  
exiting arm*

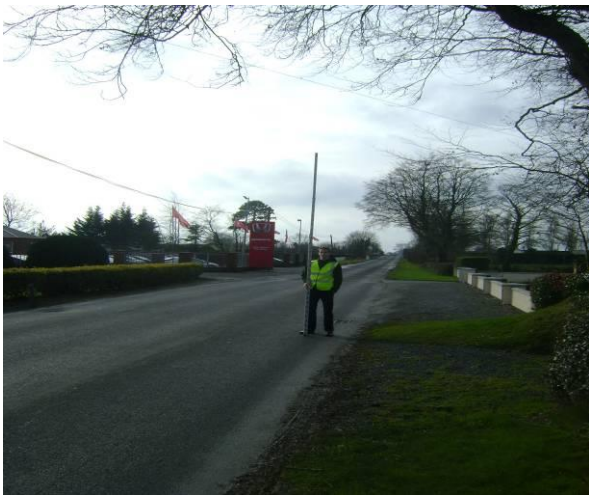
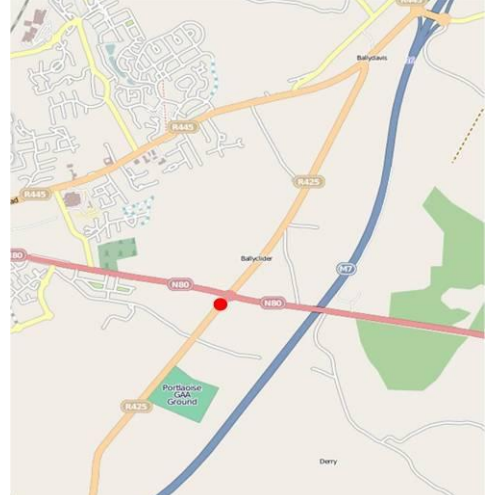
Issue 2.3.6

<b>Possible Issue or Hazard</b>	Overhead powerlines
<b>Remedial Action</b>	Upon exit of R425 / N80 junction, low hanging powerlines are immediately confronted. Shown in the image above are the powerlines with a 3.9m surveying staff fully extended used for scaling purposes. The transformer should have sufficient clearance beneath but extreme care should be taken in this area nonetheless.

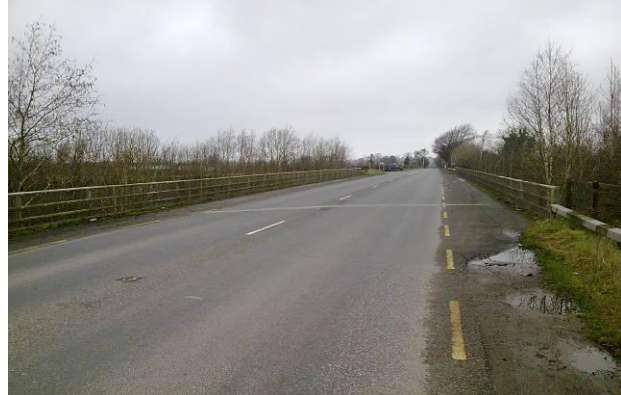
Issue 2.3.7

<b>Possible Issue or Hazard</b>	Structural integrity of M7 overbridge
<b>Remedial Action</b>	Structural assessment of M7 overbridge may be required to confirm its structural integrity before transformer can be carried across it.

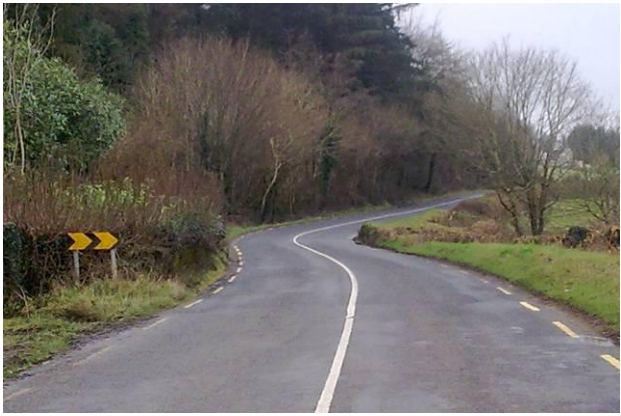
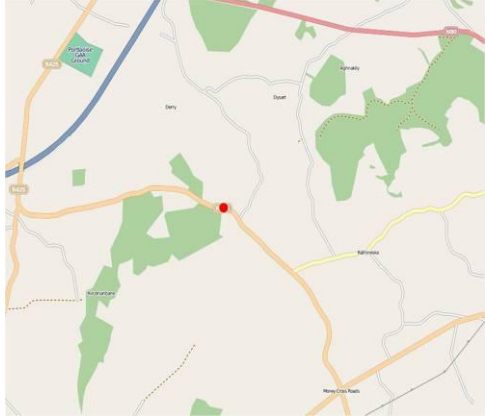
Issue 2.3.8

<b>Possible Issue or Hazard</b>	Road alignment constraint
<b>Remedial Action</b>	In general the R425 and R426 are typical single carriageway country roads. This location is the only major "pinch point" on the road where a wall on the southbound side of the road kicks out into the road edge. It is situated at the same location as minor deflections in the horizontal and vertical alignment of the road. It does not render the route impassable but care should be exercised when passing, paying particular attention to the small wall on the inside of the bend.

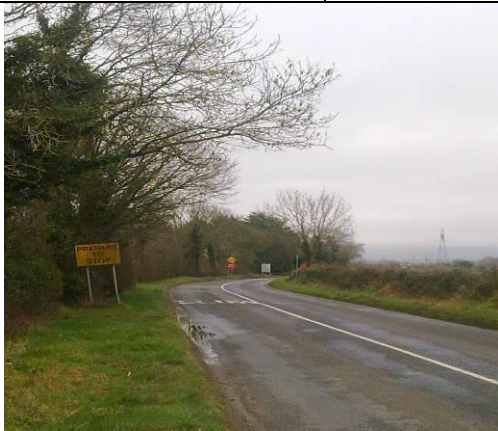
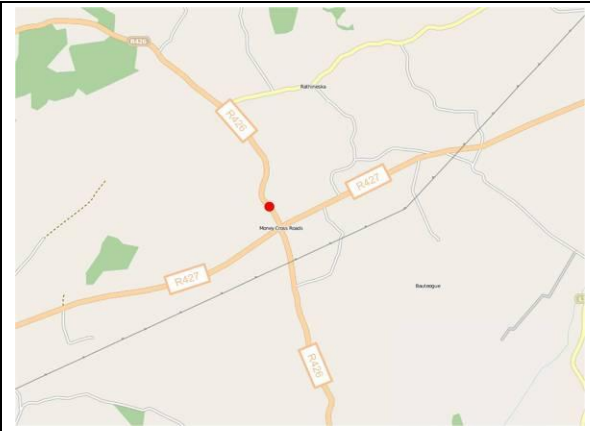
Issue 2.3.9

<b>Possible Issue or Hazard</b>	Overhanging trees
<b>Remedial Action</b>	There are several overhanging trees along the R425 / R426 typical of the one shown above. Most are quite high and should not cause any obstruction but care should be taken when passing underneath nonetheless.
