## **Appendix 11.6 AECOM Transportation: Haulage Route Assessment**

# EirGrid 400/110kV Transformer; Proposed Haulage Route Assessment

Job No 60241205

Date Created March 2012

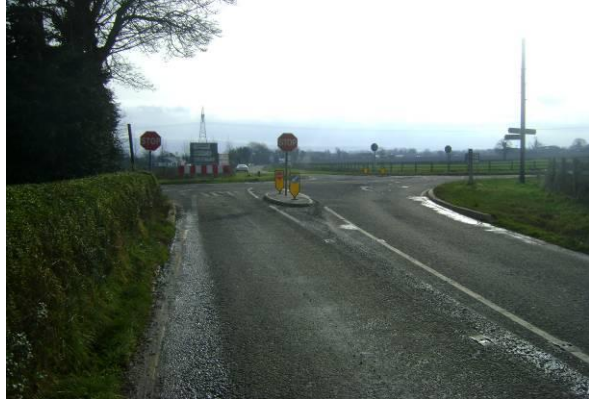
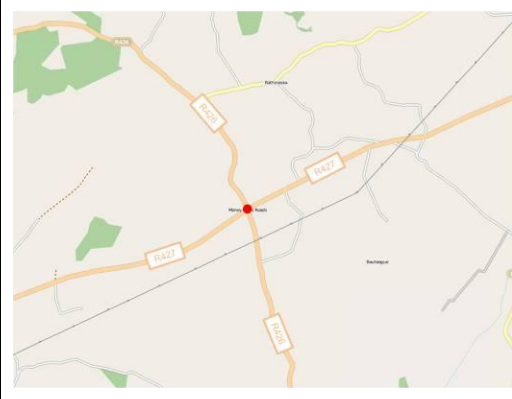
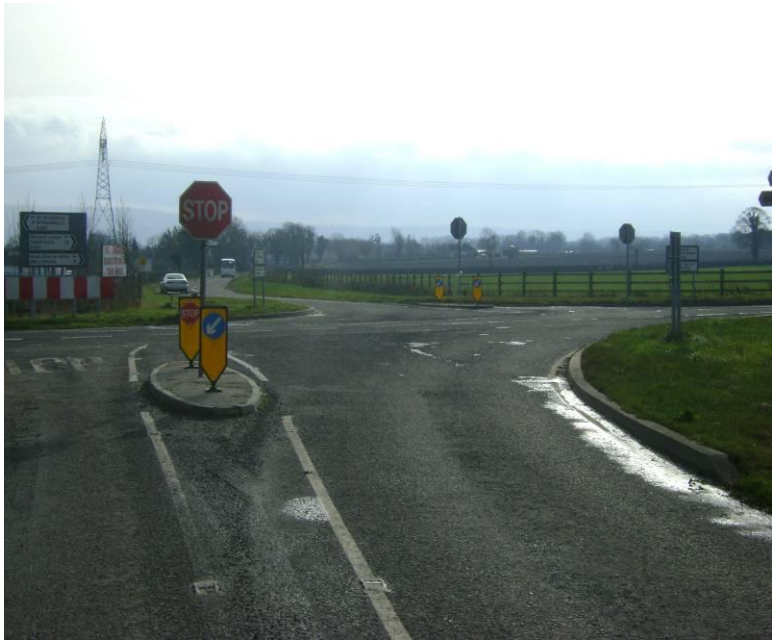
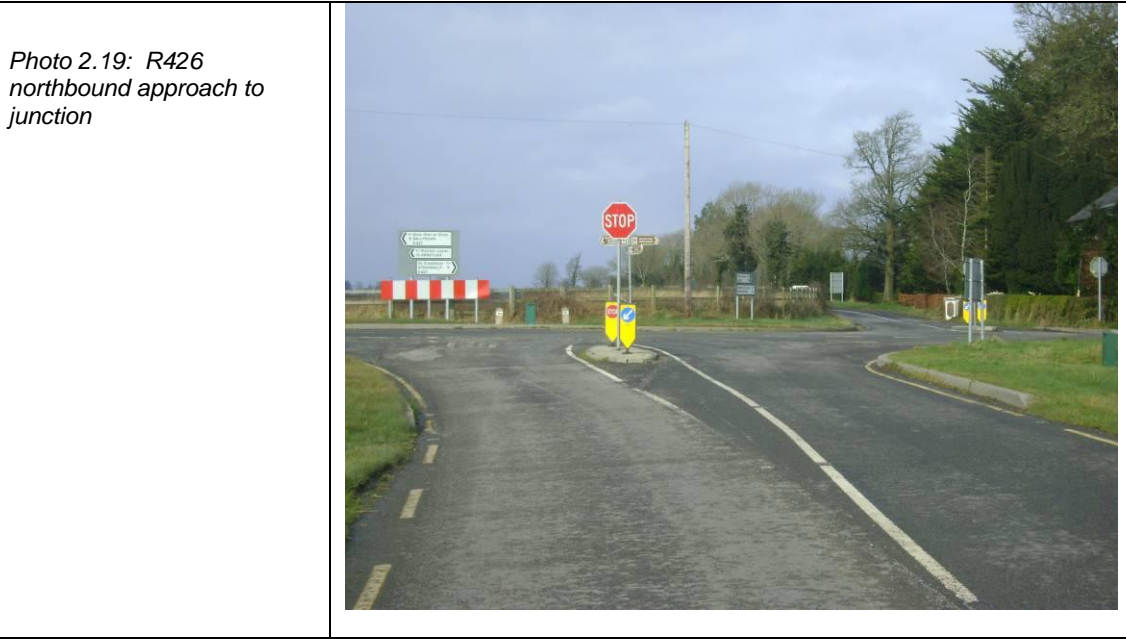
Issue 2.3.10

<b>Possible Issue or Hazard</b>	R426 / R427 staggered junction	
<b>Remedial Action</b>	<p>Carry out Autotrack sweptpath analysis on junction prior to journey being undertaken. Photos 2.18 and 2.19 below show this junction from various angles. Directly crossing this junction would not normally be hazardous, however the inclusion of two concrete islands and signage on each approach has caused it to become more awkward. The image above shows the southbound approach to the junction, the best way of negotiating this would be to use the northbound side of the R426 approach (in above image) and exit on the southbound side thereby negating the stagger as much as possible. Autotrack sweptpath analysis of the junction will confirm whether this is possible.</p>	
<p><i>Photo 2.18: Close up of R426 southbound approach to junction</i></p>
