## **Appendix 11.4 AECOM Transportation: Road Safety Audit - Coolnabacky**

# ESB Site Access Timahoe – Stage 1/2 Road Safety Audit

Job No 60273170

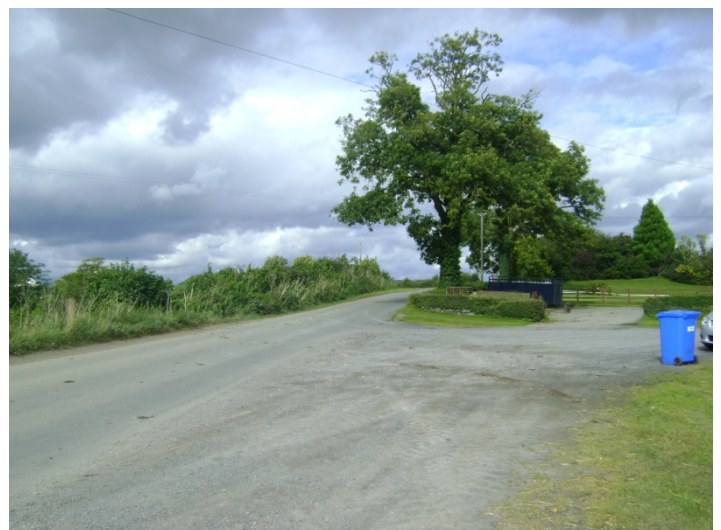
- The R426 is approximately 5.5m wide in the vicinity of the proposed site access, and runs in a north south direction fronting the site.
- Visibility to the north (right) from the proposed access road is restricted due to a large tree. The road rises from the site access for a distance of 100m before it levels off and bends to the west.
- Visibility to the south (left) from the proposed access road is approximately 70m. The road is relatively level heading south, and bends slightly to the east.
- No road markings were visible on the road fronting the proposed access road.
