## **Appendix 11.5 AECOM Transportation: Road Safety Audit - Ballyragget**

# ESB Site Access Ballyragget – Stage 1/2 Road Safety Audit

Job No 60273241

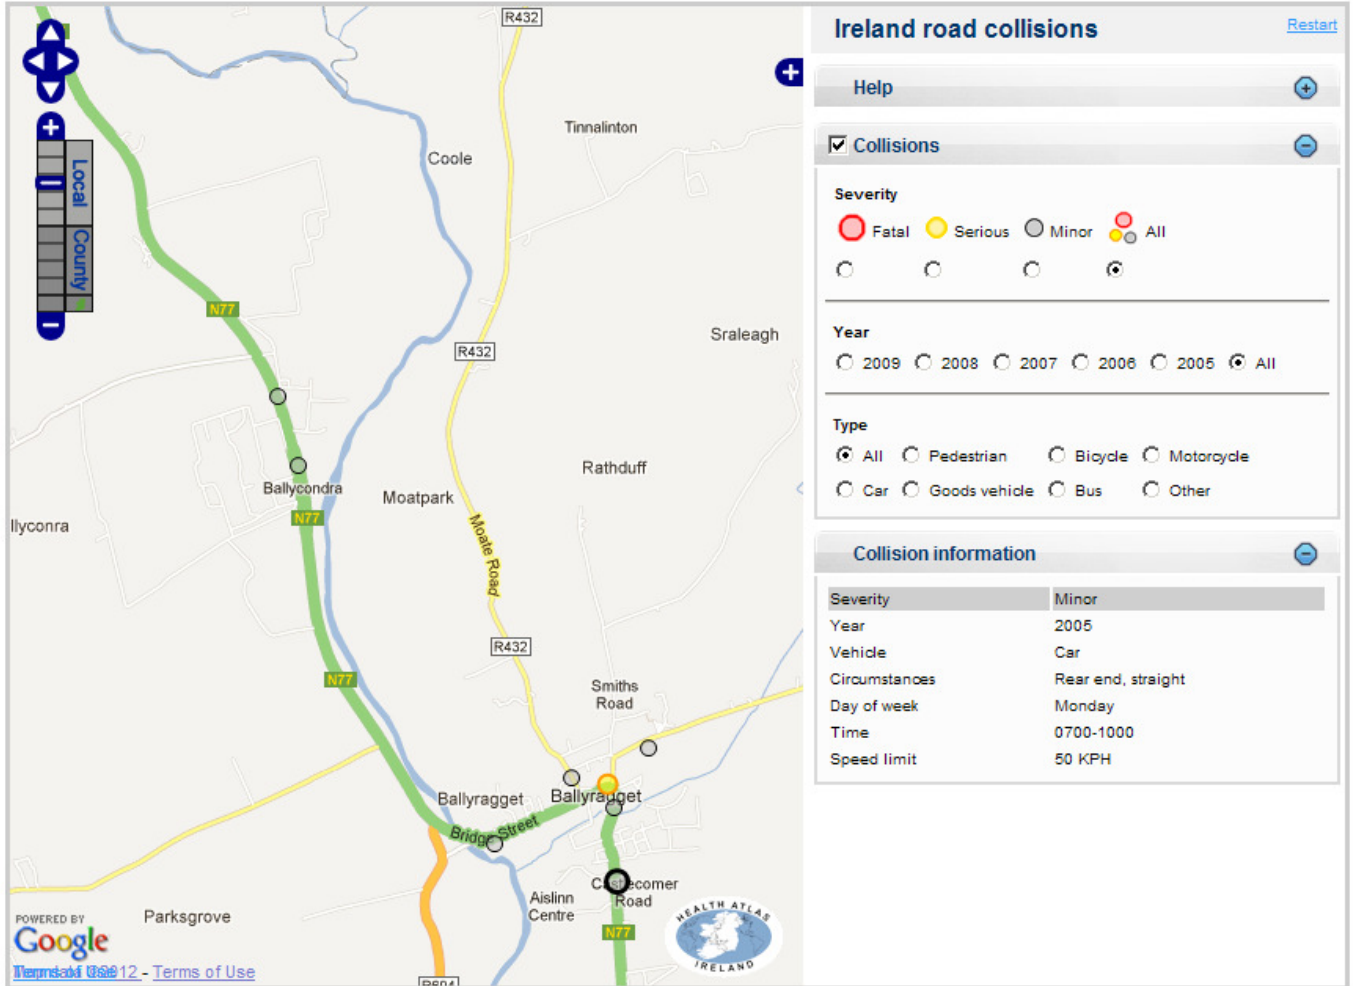
- The Road Safety Authority database of personal injury accidents was interrogated to establish if there are any existing safety issues in the vicinity of the development that are not evident from the site visit. The period of accident data examined is from 2005-2009.
- The records indicate that there were no accidents in the vicinity of the proposed works.

Figure-2: RSA Accident Records (2005-2009) in vicinity of proposed scheme (www.RSA.ie)
