## **Appendix 11.6 AECOM Transportation: Haulage Route Assessment**

# EirGrid 400/110kV Transformer; Proposed Haulage Route Assessment

Job No 60241205

Date Created March 2012

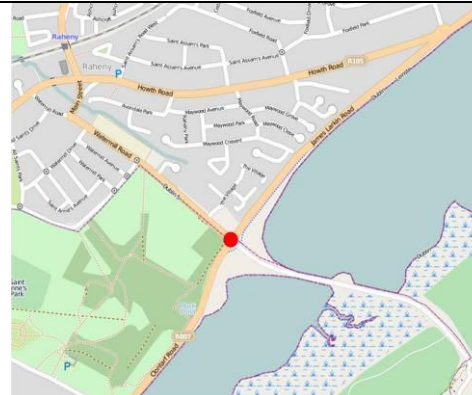
Issue 2.1.6

<b>Possible Issue or Hazard</b>	Turning left onto Watermill Road.
<b>Remedial Action</b>	Carry out Autotrack sweptpath analysis on junction prior to journey being undertaken. Manoeuvre made easier as there is no central island on the Clontarf Rd approaching arm.

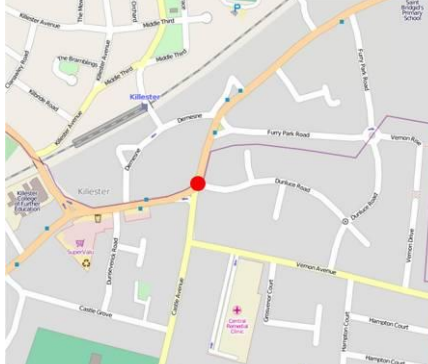
Issue 2.1.10

<b>Possible Issue or Hazard</b>	Narrow approach and central refuge island with pedestrian guard rails upon exit.
<b>Remedial Action</b>	Carry out Autotrack sweptpath analysis on junction prior to journey being undertaken. Remove lit traffic bollards on central island on entry of bend to facilitate overrun of island if necessary. Photo 2.2 below shows the junction from the reverse angle and displays a relatively wide exit through the junction which is facilitated by the presence of a bus lane.
<i>Photo 2.2: Howth Road / Dunluce Road junction looking northeast</i>

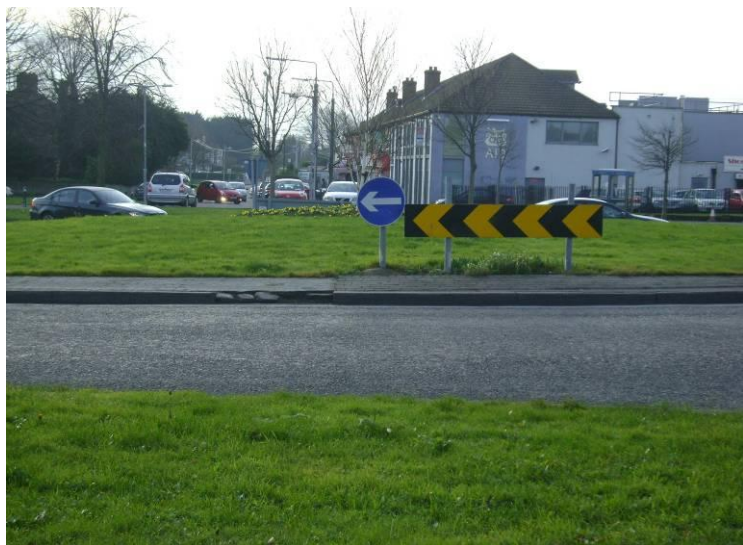
*Photo 2.5: Looking east across Artane Roundabout.*

<b>Possible Issue or Hazard</b>	Artane Roundabout	
<b>Remedial Action</b>	<p>Carry out Autotrack sweptpath analysis on junction prior to journey being undertaken. The Artane roundabout is the first major roundabout encountered on the haulage route. The image above shows the northbound approach from which the transportation unit will be approaching. Entry width is good, however, the deflection angle upon entry means entirely avoiding the central island will probably not be possible. As the island is not particularly high or steeply banked on the sides the most prudent options would be lay down a track for the right hand side of the vehicle to travel along while the left hand side stays on the road. This method of crossing will require the temporary removal of three sets of chevron boards and three supplementary keep left signs. Photo 2.4 below shows a generous width on the circulating carriageway. Photo 2.5 shows the side profile of the central island (looking east) which should not be particularly difficult to cross with the transportation unit.</p>

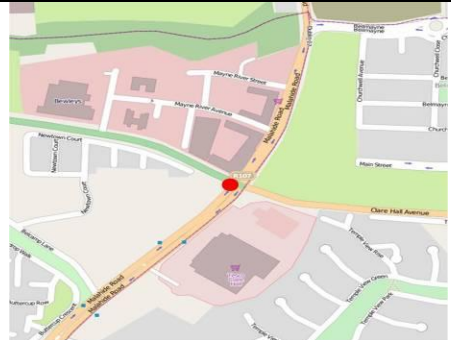
Issue 2.1.19

<b>Possible Issue or Hazard</b>	Turning left off Malahide Road onto R139.	
<b>Remedial Action</b>	Carry out Autotrack sweptpath analysis on junction prior to journey being undertaken. The left turn filter lane here is quite wide and as such may facilitate the passing of the transportation unit. The transportation unit will use the outermost lanes on the northbound approach and aim to approach the filter lane in as straight a formation as possible. After passing through here the median between the eastbound / westbound carriageways on the R139 may be mounted to allow the transportation unit to straighten and continue along the R139 westbound. If this approach does not work, an alternative method of negotiating the junction may be to approach on the outermost lane of the northbound carriageway and in order to increase the turning radius of the corner, exit on the eastbound carriageway of the R139 before mounting the median further down to return to the westbound carriageway of the R139, see Figure 2.1 below. Autotrack sweptpath analysis of the junction will determine which method is most likely to be used.

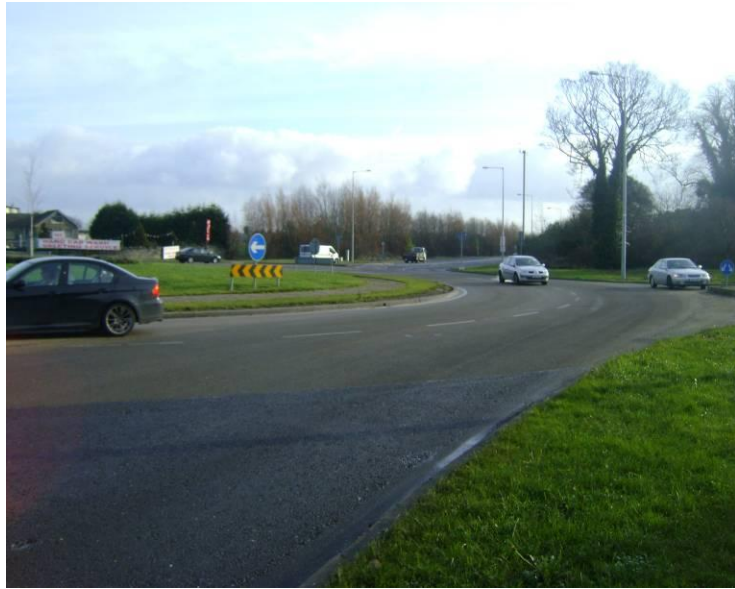
<b>Possible Issue or Hazard</b>	R139 Roundabout at Bewleys Hotel	
<b>Remedial Action</b>	<p>Carry out Autotrack sweptpath analysis on junction prior to journey being undertaken. The Roundabout at the Bewleys Hotel is the last major roundabout encountered on Section1 of the route. Similar to the Darndale Roundabout, it has a low deflection angle upon entry and exit and hence facilitates relatively easy access to and exit from the roundabout. The entry, exit and circulating carriageway are all two lanes in width (see Photos 2.8 and 2.9 below). It can also be seen in Photo 2.8 below that there is an overrun strip running along the inside edge of the central island which will facilitate the mounting of the island if necessary. If this is required it will also require the temporary removal of two chevron boards and two keep left signs. Autotrack sweptpath analysis of the junction will establish if this is necessary.</p>

*Photo 2.9: Looking south  
upon exit of Bewleys  
Roundabout*

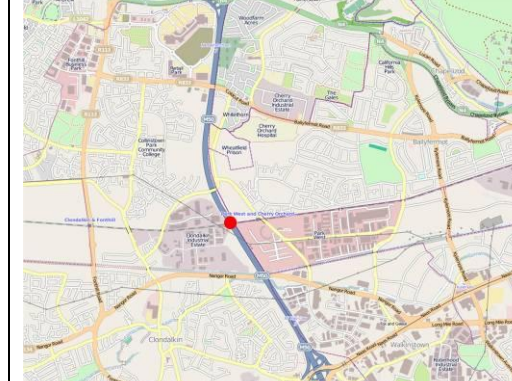
*Issue 2.2.2*

<b>Possible Issue or Hazard</b>	Structural integrity of railway overbridge (OBC10A) Dublin – Cork line
<b>Remedial Action</b>	Irish Rail require structural integrity of railway overbridge to be confirmed via an independent structural assessment.

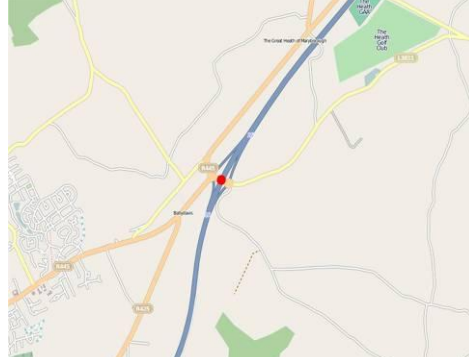
Issue 2.3.2

<b>Possible Issue or Hazard</b>	Structural integrity of M7 overbridge.	
<b>Remedial Action</b>	Possible structural integrity issues with M7 overbridge. A structural assessment may be required prior to transportation of transformer being undertaken to ensure it is structurally sound.

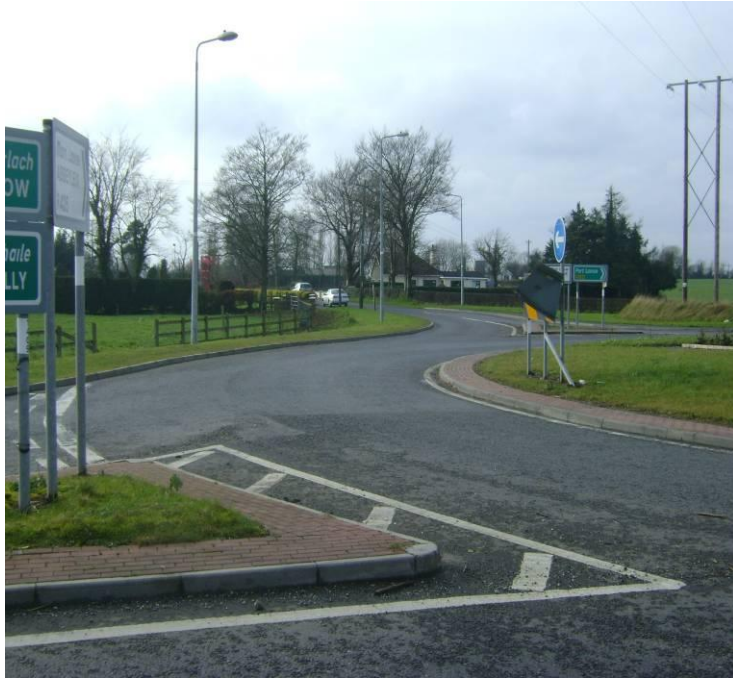
<b>Possible Issue or Hazard</b>	Roundabout at junction of R425 and N80
<b>Remedial Action</b>	Carry out Autotrack sweptpath analysis on junction prior to journey being undertaken. The above image shows the southbound approach to the R425 / N80 junction. It can be seen it is only a single lane approach and the deflection angle upon entry is higher than those encountered at previous roundabouts. It has a relatively wide circulating carriageway but is technically still one lane, see Photo 2.16 below. It is anticipated the central island will need to be mounted here to successfully negotiate the junction. Temporary removal of one set of chevron boards and keep left arrow will be required to facilitate this. Autotrack analysis will determine to what degree the island must be encroached upon.
<i>Photo 2.15: View of deflection upon entry to roundabout</i>

*Photo 2.16: Circulating  
carriageway width*

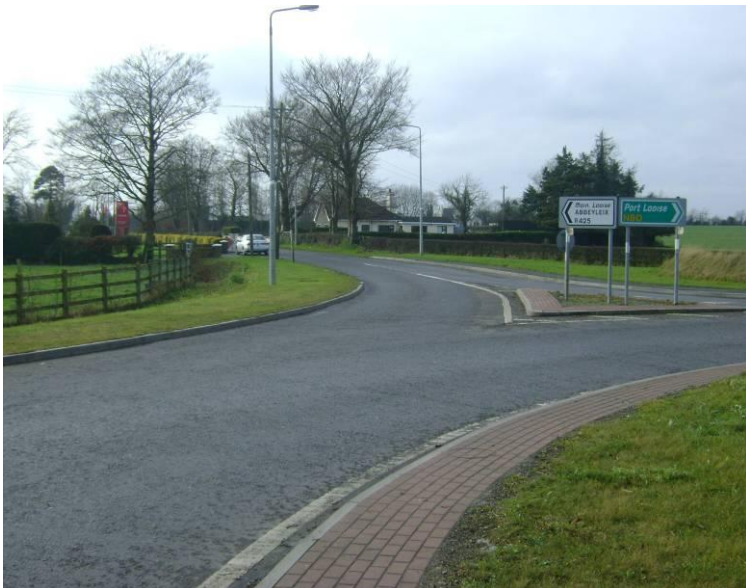
*Photo 2.17: Looking  
southwest towards R425  
exiting arm*

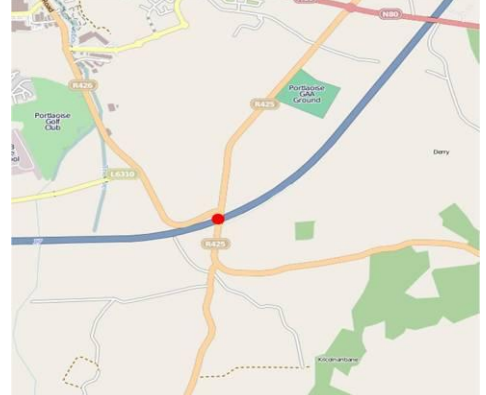
Issue 2.3.7

<b>Possible Issue or Hazard</b>	Structural integrity of M7 overbridge
<b>Remedial Action</b>	Structural assessment of M7 overbridge may be required to confirm its structural integrity before transformer can be carried across it.
